Wild Fish Conservancy Watertype Assessment Project Summary West Sound Watersheds Phase III

September 2016

West Sound Watertype Assessment Project –Phase III

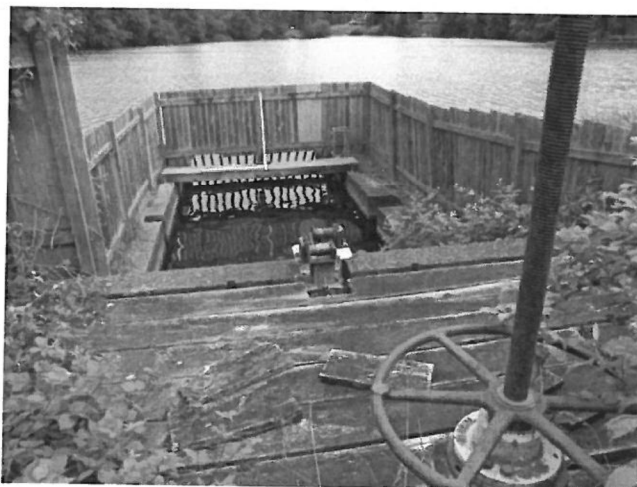
Levee blocks mouth of cove, culvert drains to sound. Barrier at all tides, control structure at upstream end to retain saltwater in the cove. Additional structure ~250m to the south: tidegate has failed and acts as dam/ cove water level control.

Culvert outlet has failed, downstream section has settled into the sand and gravel

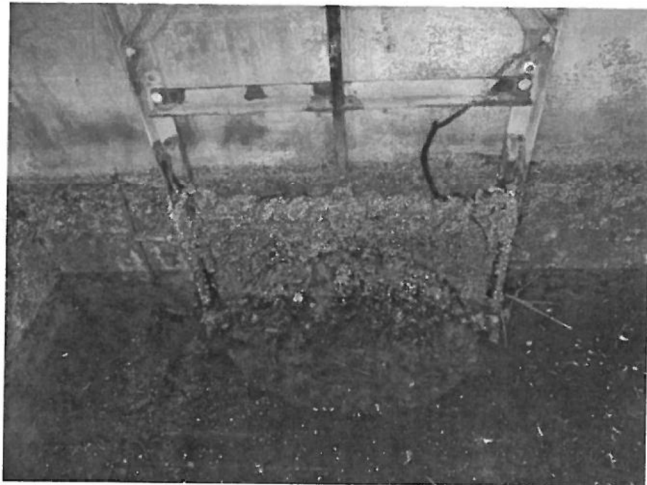
Levee blocks mouth of cove, culvert drains to sound. Barrier at all tides, control structure at upstream end to retain saltwater in the cove. Additional structure ~250m to the south: tidegate has failed and acts as dam/ cove water level control.

Culvert outlet has failed, downstream section has settled into the sand and gravel

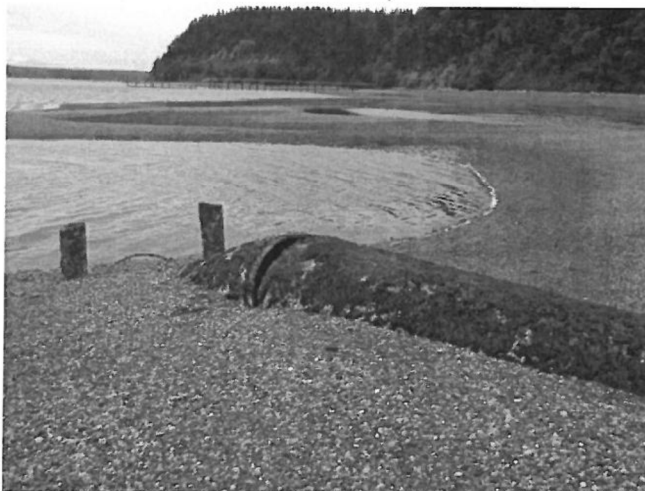
Levee blocks mouth of cove, culvert drains to sound. Barrier at all tides, control structure at upstream end to retain saltwater in the cove. Additional structure ~250m to the south: tidegate has failed and acts as dam/ cove water level control.

Culvert outlet has failed, downstream section has settled into the sand and gravel

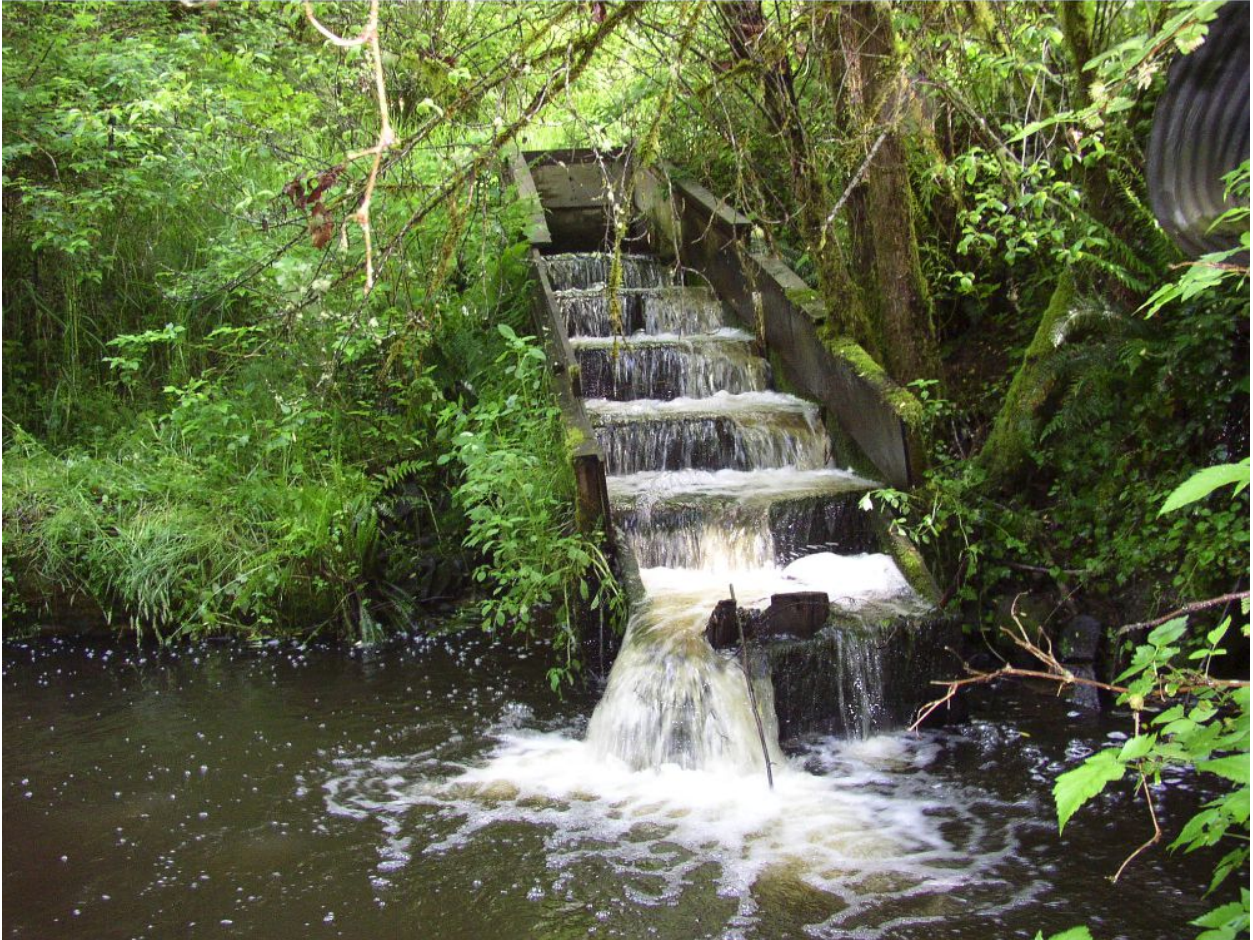
DU-FP01 – Earthen dam and fishway

DU-FP01 on the map below is an earthen dam with a failing fish ladder. While WFC did not have access to that site, info is provided in the Key Peninsula - Island Basin Plan (Pierce County, 2006). Further, the site was a short-lived Family Forest Fish Passage Program project until it was withdrawn, so there is additional information in PRISM under project #05-1408 (SPSSEG).

Fishway at dam, site DU-FP01. The fishway consists of a six-step wooden weir ladder fed by an 18 inch culvert at its top. This site was a FFFPP project (05-1408, SPSSEG), but the project was withdrawn prior to permitting.

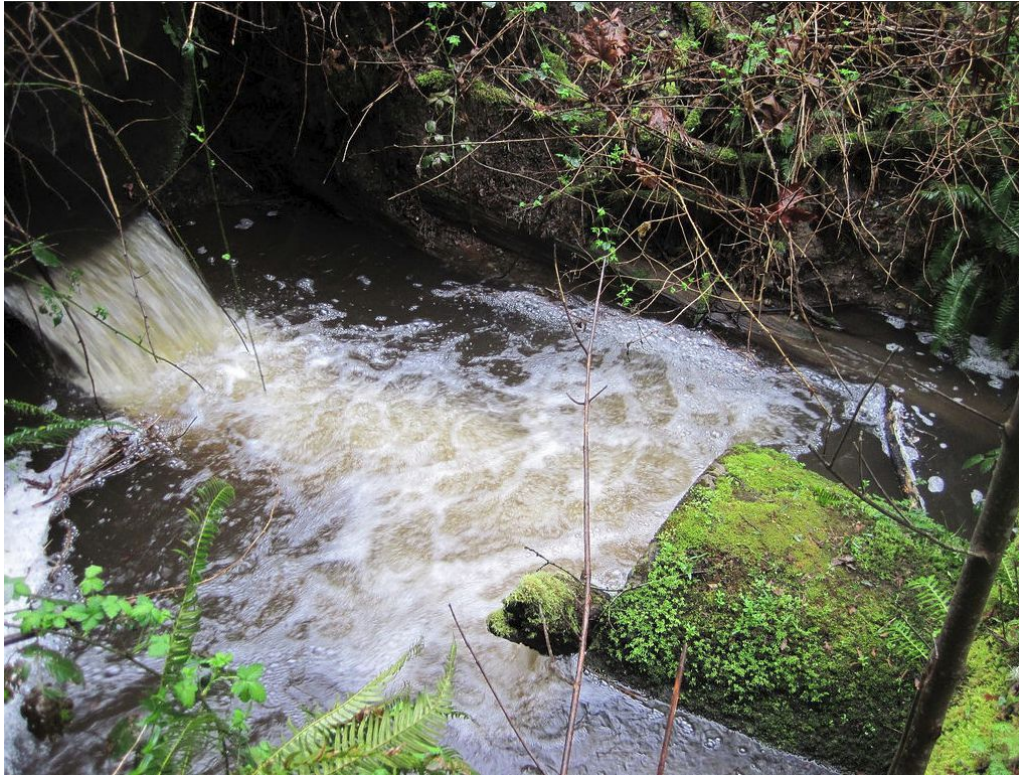
DU-CR04 - Lackey Road Culvert

DU-CR04 on the map below is an undersized failing culvert at Lackey Rd. that is a partial barrier to fish passage.

Lackey Rd. culvert outlet, with culvert sections in plunge pool. This undersized 5.0 foot span culvert should be replaced with a 16 foot box culvert or bridge. In conjunction with improving passage at the downstream earthen dam, restoring fish passage here would improve spawning and rearing habitat to almost 3 miles of mainstem and tributary channel to Coho, Steelhead and Cutthroat trout. Additional photos and data are available on WFC's interactive web map at: <http://wildfish.beardedmaps.com/?lat=47.31707&lng=-122.76959&zoom=19>

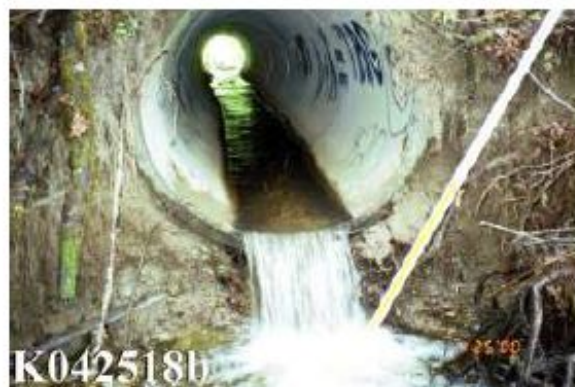
Comments
Bottom section has fallen into plunge pool, causing scouring, measurements are for smaller plunge pool below pipe. Larger pool formed before section broke off.

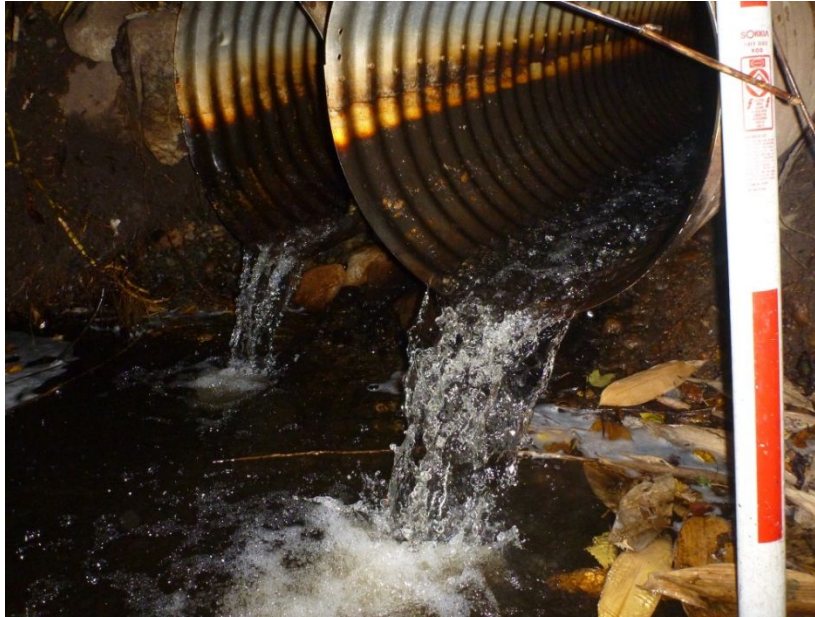
Project C High	BI51	point ID 8698	The two culverts draining Issei Creek under Miller Rd. NE are partial barriers to upstream fish migration and disruptive to natural stream processes.	Replace the two side by side 2 ft. culverts under Miller Rd. NE. with a large single culvert or bridge. Remove the downstream English Ivy and invasive Bamboo. Revegetate the riparian corridor with native plant species to increase bank stabilization	Issei Creek provides over a mile of excellent fish habitat on Bainbridge Island. Beginning in wetland headwaters, the stream meanders through a lush second growth forest in the Grand Forest Park before feeding into Fletcher Bay.

Outlet of the side by side culverts running under Miller Rd. NE. Perched 1 ft and undercut.

Replace the two side by side 2 ft. culverts under Miller Rd. NE. with a large single culvert or bridge. Remove the downstream English Ivy and invasive Bamboo. Revegetate the riparian corridor with native plant species to increase bank stabilization.

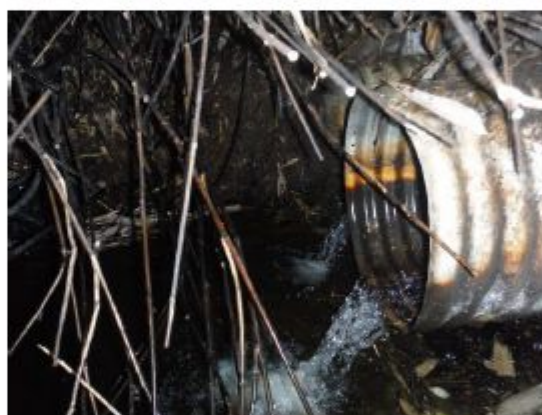
Both pipes have internal grade breaks. Us and DS ends of pipes are CAL, middle of pipe is PCC.

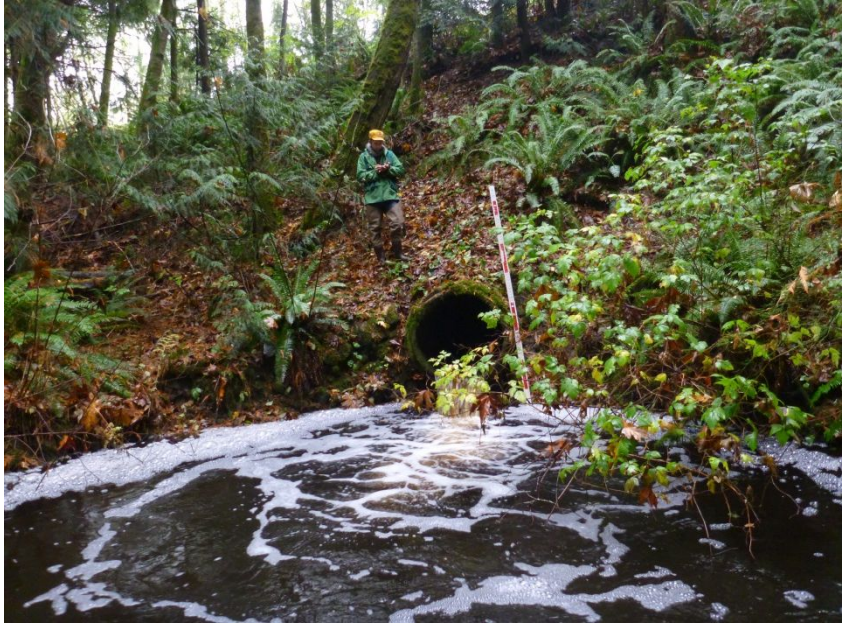
Priority	Stream	GPS point	Problem/opportunity	Potential solution	Comments
Project D High	BI56	point ID 8711	Manzanita Creek crosses Miller Rd. NE in a barrier culvert perched 1.3' into a large plunge pool.	Replace the undersized and perched culvert with a larger culvert capable of carrying Manzanita Creek's flows during all flood cycles. Remove or redesign the downstream weirs and regrade the stream channel to match the new culvert. Replant the riparian corridor to improve bank stability.	Manzanita Creek is one of the largest watersheds on Bainbridge Island, and provides habitat for numerous fish and amphibian species. There were multiple restoration opportunities and partial barrier culverts found on this system during WFC's field survey, though the majority were in the headwaters of this system. The most prominent disruption to fish migration and natural stream process was found where Manzanita Creek is piped under Miller Rd. NE. Here, the concrete culvert is 3 ft in diameter and the outfall is perched 1.3 ft. The undersized culvert constricts flow during high flow events resulting in substantial downstream erosion and a large plunge pool.

Miller Rd. NE Culvert outlet perched 1.3 ft into a large plunge pool.

Solution: Replace the undersized and perched culvert with a larger culvert capable of carrying Manzanita Creek's flows during all flood cycles. Remove or redesign the downstream weirs and regrade the stream channel to match the new culvert. Replant the riparian corridor to improve bank stability.

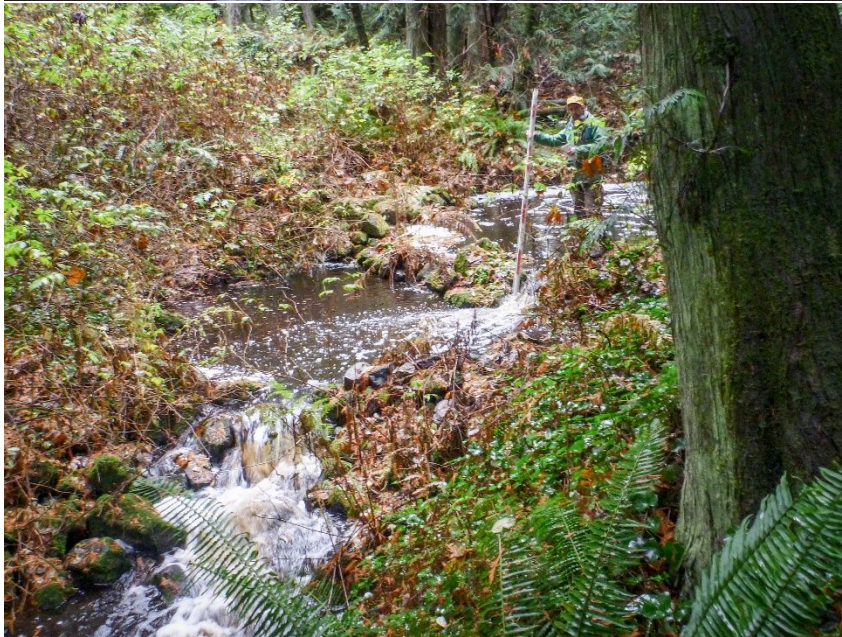
Two boulder weirs downstream from the Miller Rd. NE plunge pool.

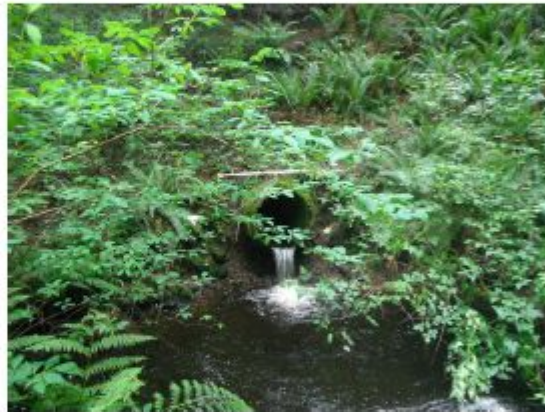
Comments
Rock dam is plunge pool control.

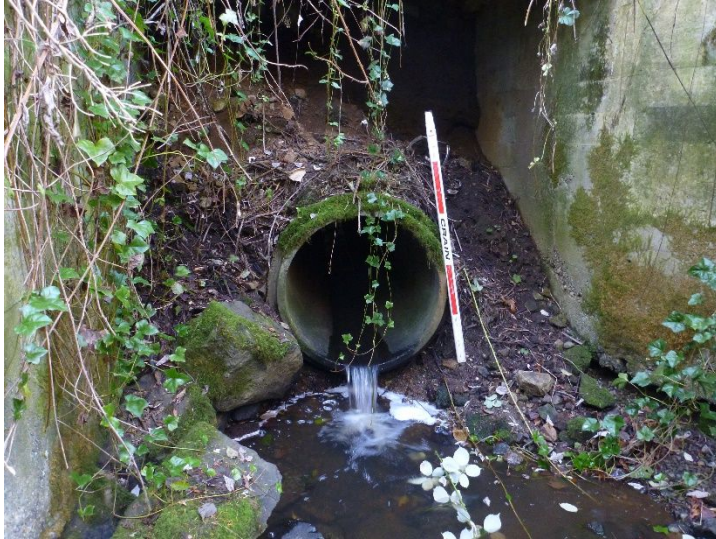
NE Country Club Rd. culvert outlet perched 1 ft with concrete retaining wall.

Replace the undersized culvert on NE Country Club Rd. with a large box culvert or bridge. Install grade controls / roughness in the channel above the culvert which is currently incised. Remove the extensive english ivy above the crossing and revegetate the riparian corridor with native plant species. Coordinate with the IslandWood education center to remove the derelict dam and restore fish passage and sediment/wood transport.

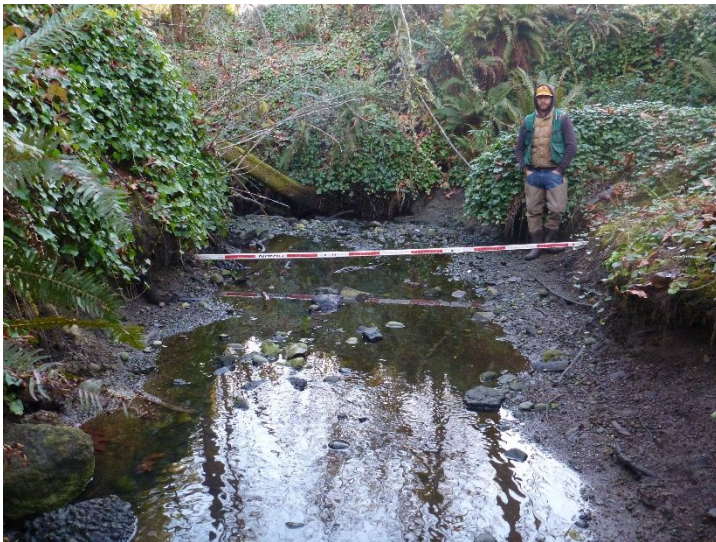
Mac's Creek with extensive English Ivy at the Blakley Harbor Park

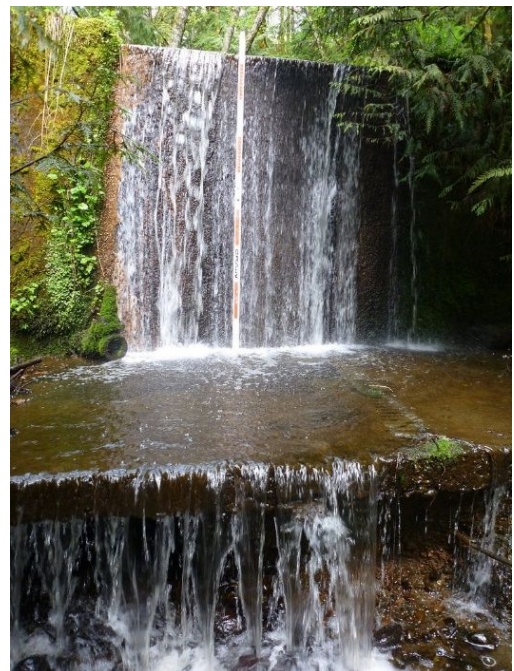
education center has shown great interest in removing the dam if the NE Country Club Rd. culvert was replaced and fish once again had access to their property.

Derelict dam on the IslandWood education center

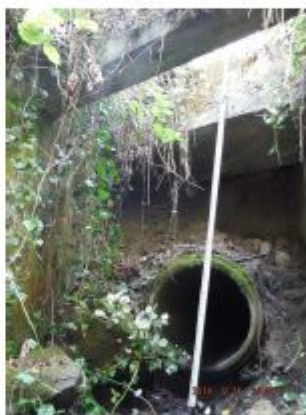
Comments
Tidally influenced, 3m retaining wall RB US, visited site at 13:53 at approximately low tide.
