## Wild Fish Conservancy Watertype Assessment Project Summary

### West Sound Watersheds Phase II

October 2014

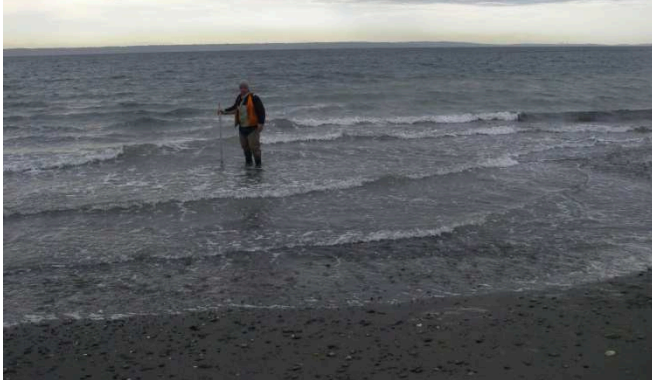
Looking downstream from the tide gate to the culvert outlet buried under the high tied.

**The Problem:** The tide gate located at Point No Point Lighthouse County Park acts as a partial barrier to upstream fish migration. It compromises fish access to 10,200 feet of Type F water and disrupts estuarine function and natural water, wood, and sediment transport processes.

**Proposed Solution:** Restore fish (and other) passage at the tide gate.

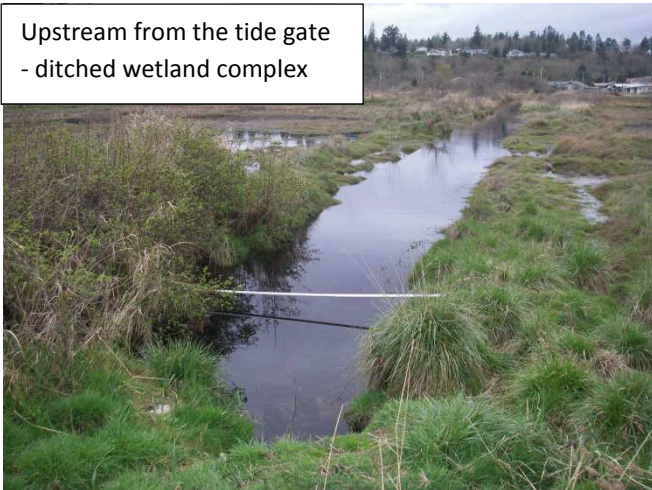
Upstream from the tide gate - ditched wetland complex

**The Problem:** Where Point No Point creek leaves its forested ravine it distributes across a reed canary grass field with no defined channel. The saturated field then drains into a ditchline to the north. This disconnect is likely a result of wetland degradation, channel ditching and flow modification around Hillview Ln. NE.

**Proposed Solution:** Naturalize the channel. This would entail reconstructing a sinuous channel, installing LWD, and planting native riparian corridor to restore natural processes and improve upstream and downstream connectivity.

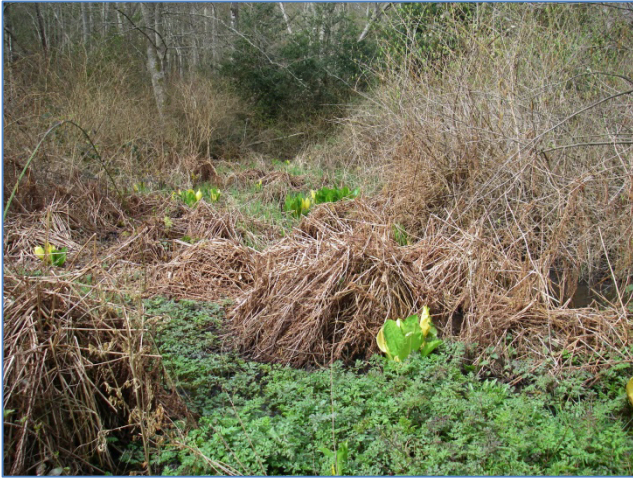
Looking upstream where the ravine distributes into wetland habitat

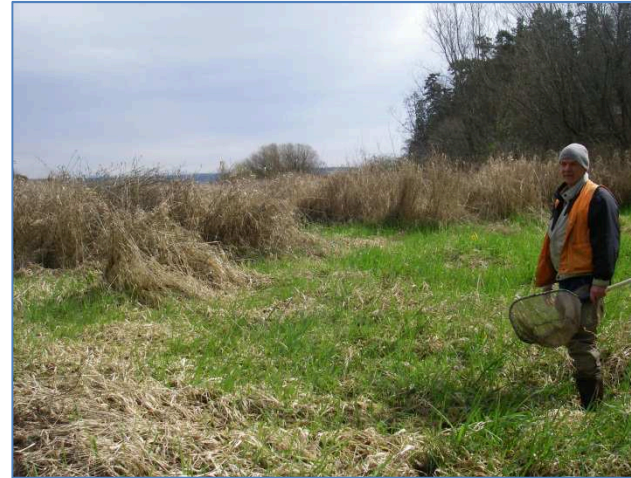
Looking downstream at the reed canary grass wetland habitat

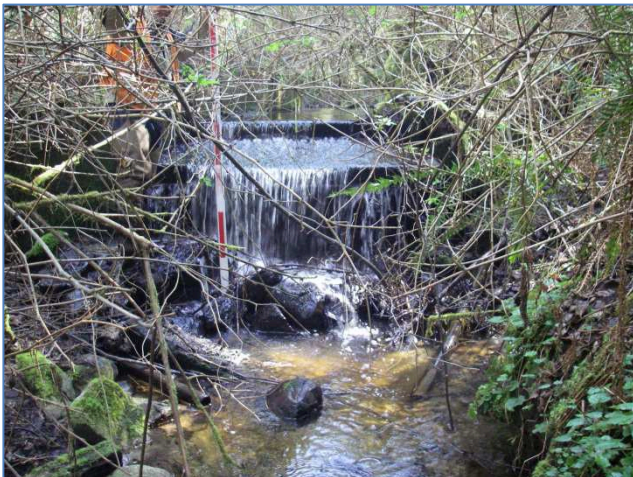
**The Problem:** The old water retention dam diverts Point No Point Creek into a 7' wide by 20' long concrete flume with a 3' high drop onto cobbles. The dam structure blocks fish migration and sediment transport.

Looking upstream at the old dam structure outfall

**Proposed Solution:** Remove the dam structure and restoring fish passage and natural stream processes

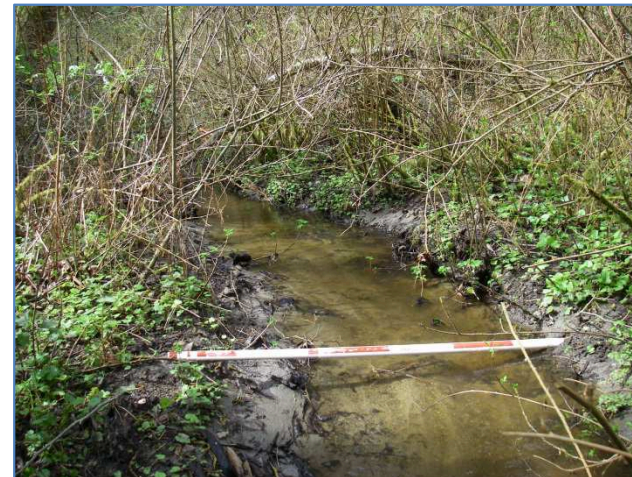
Point No Point creek below the old dam

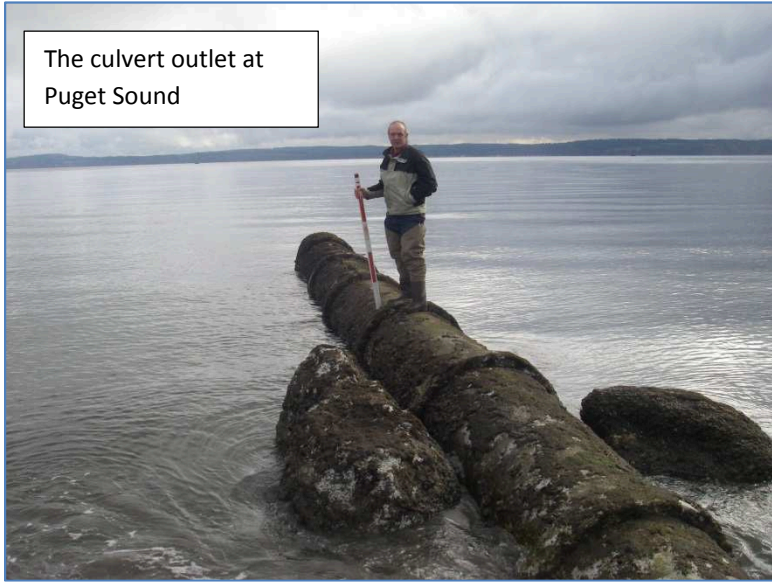
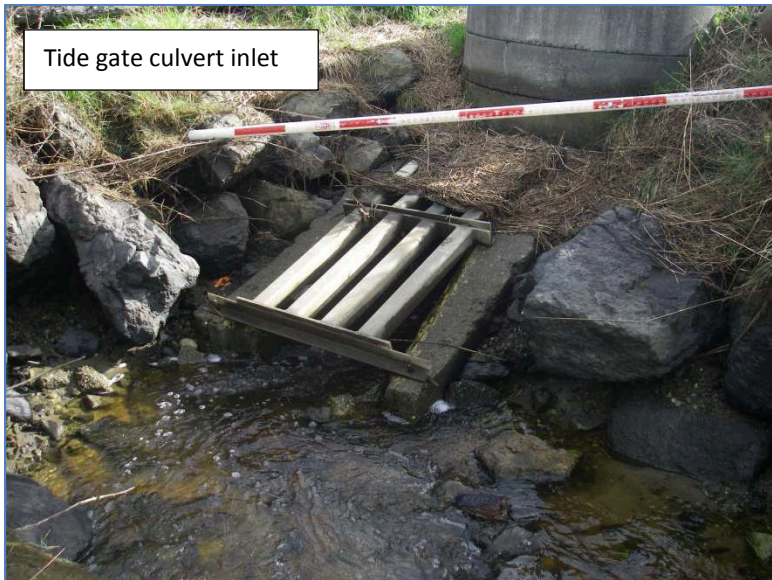
**The Problem:** The tide gate located at Norwegian Point County Park acts as a partial if not full barrier to upstream fish migration. It compromises fish access to 10,000 feet of Type F water and disrupts estuarine function and natural water, wood, and sediment transport processes.

**Proposed Solution:** Restore fish (and other) passage at the tide gate.

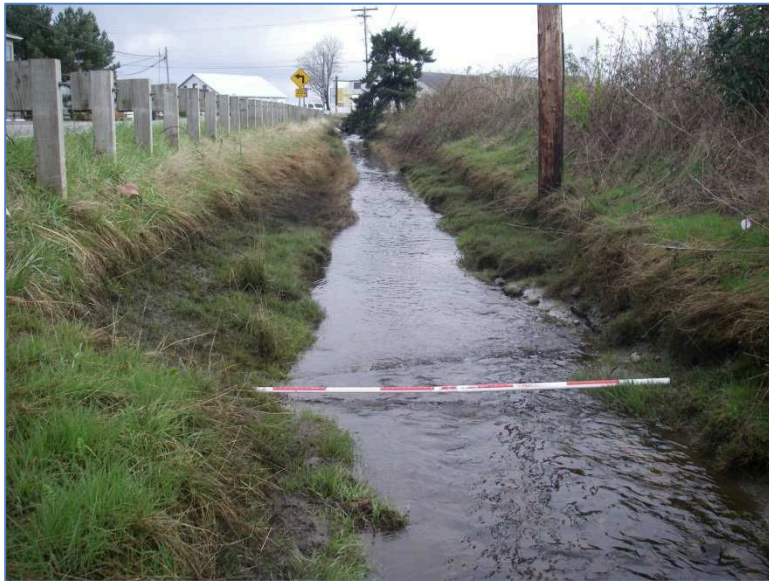
**The Problem:** Finn Creek has been ditched along the east side of Hansville Rd. NE.

Finn Creek ditched along the east side of Hansville Rd. NE

**Proposed Solution:** Naturalize the channel within the Norwegian Point County Park. This would entail reconstructing a sinuous channel, installing LWD, and planting native riparian corridor to restore natural processes and improve upstream and downstream connectivity.

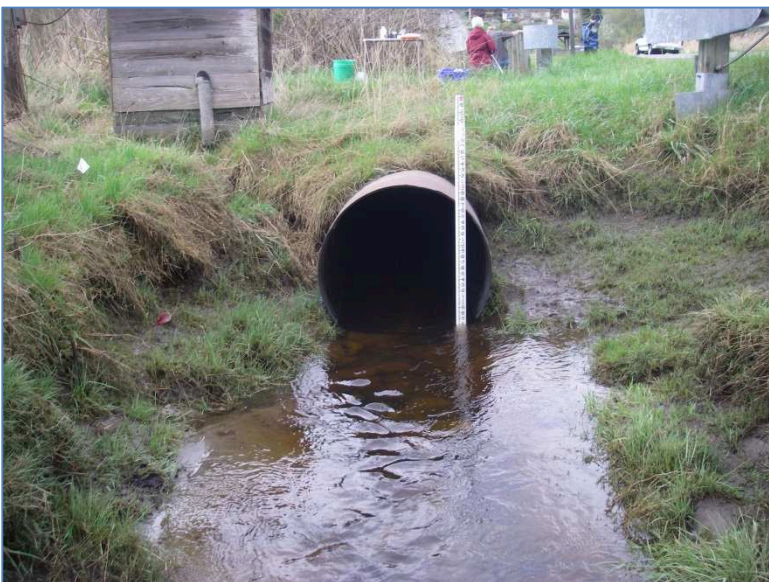
Non barrier field access road culvert outlet on the ditched Finn Creek

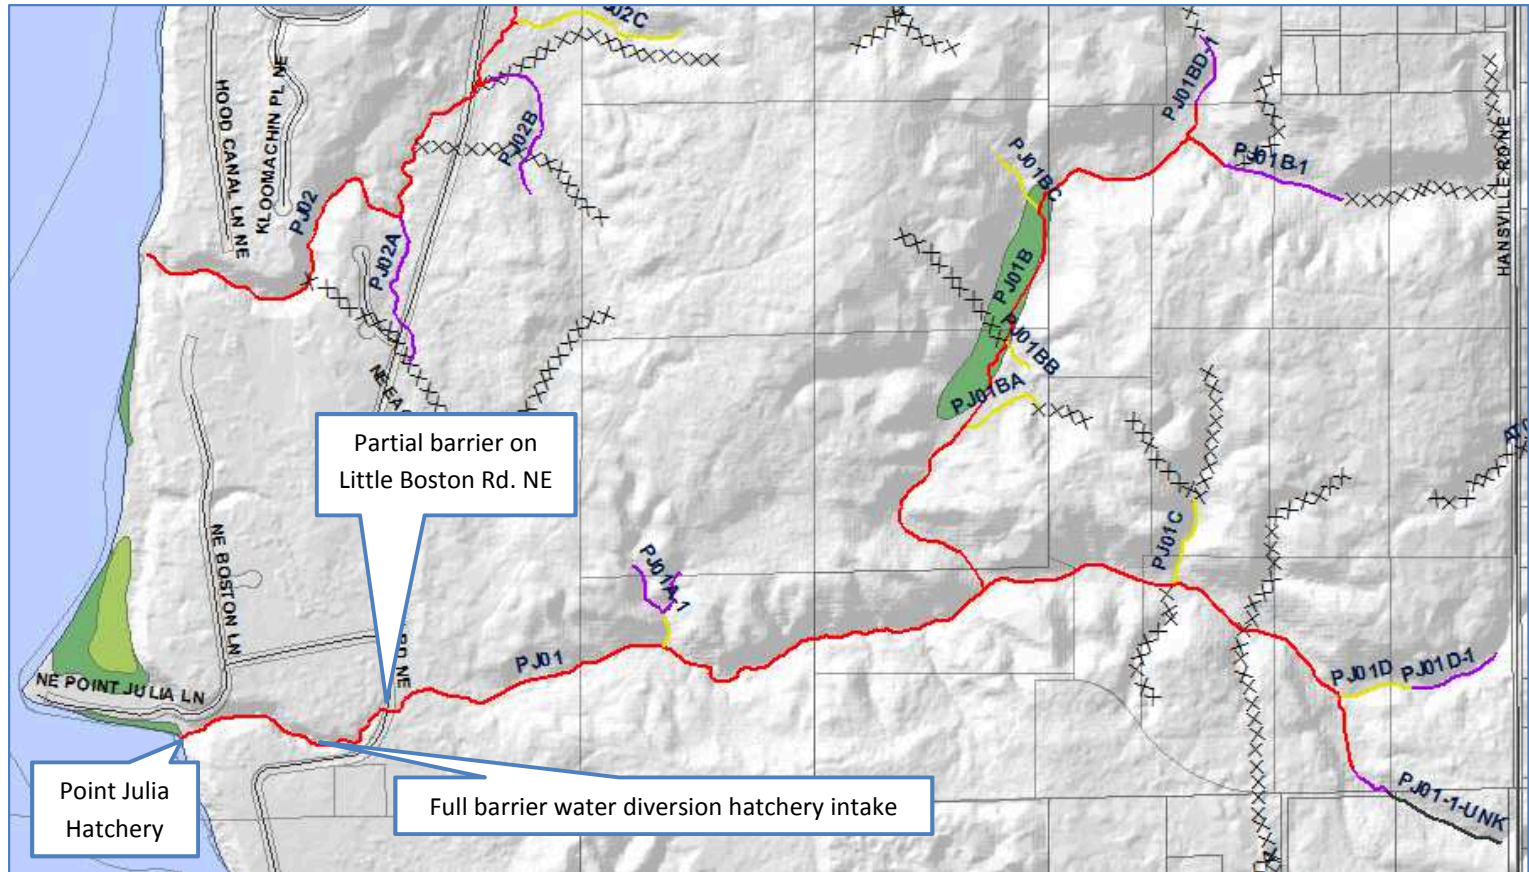
**The Problem:** Little Boston Creek is screened off where its flows enter a holding pen. The flows are then passed through a fishway and into the Puget Sound.

**Proposed Solution:** Restore wild fish passage around the hatchery.

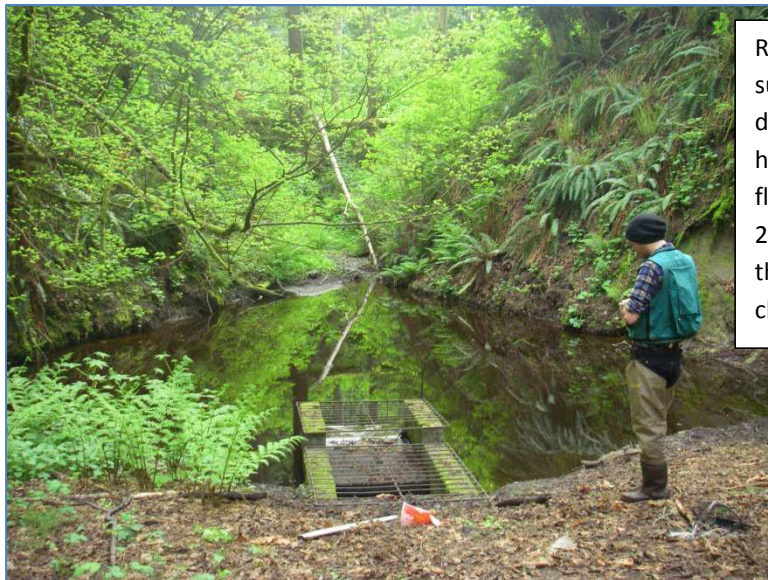
**The Problem:** The outlet of the intake reservoir for the downstream hatchery is a full barrier to fish passage. The diversion partially de-waters 450 feet of the mainstem channel. The flow which is not piped into the hatchery runs out the overflow structure to continue downstream the mainstem. This overflow passes through a debris screen and drops 5' into a concrete vault. The vault then drains into a 2.5' culvert which is buried under the downstream bank and is perched 2' at its outlet.

Reservoir where surface water is diverted into the hatchery. Remaining flows feed through 2.5' culvert and into the downstream channel.

**Proposed Solution:** Restore fish passage around the reservoir.

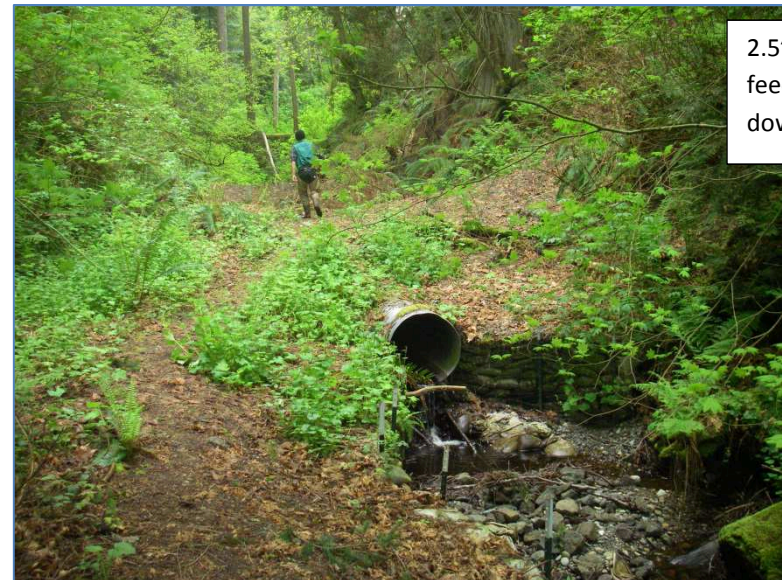
2.5' culvert outlet feeding into the downstream channel

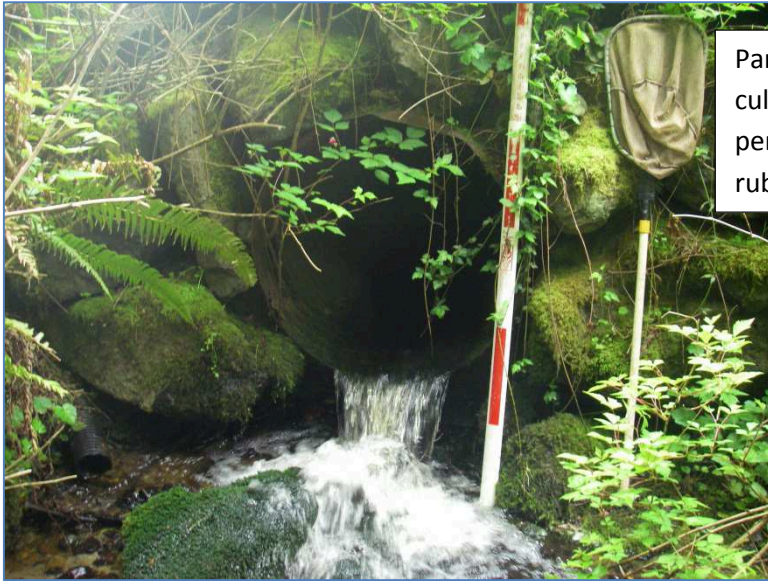
**The Problem:** Little Boston Creek crosses Little Boston Rd. NE in an undersized culvert perched 1'. Cutthroat trout were netted above and below this partial barrier culvert.

Partial Barrier culvert outlet perched 1' onto rubble.

**Proposed Solution:** If downstream habitat is restored this culvert may be a good candidate for replacement, improving fish passage.

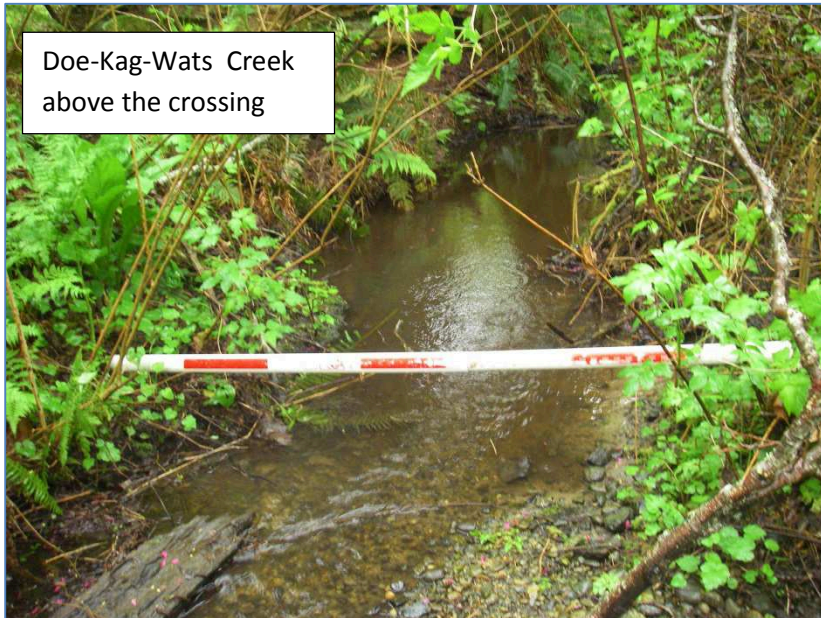
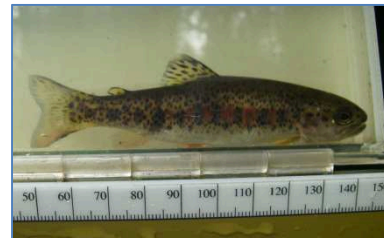
**The Problem:** The upper reaches of Doe-Kag-Wats Creek crosses a Suquamish forest access road in a partial barrier culvert with a 0.5' perch. The culvert affects access to 4,000 feet of fish habitat.

**Proposed Solution:** Replace culvert to improve fish passage

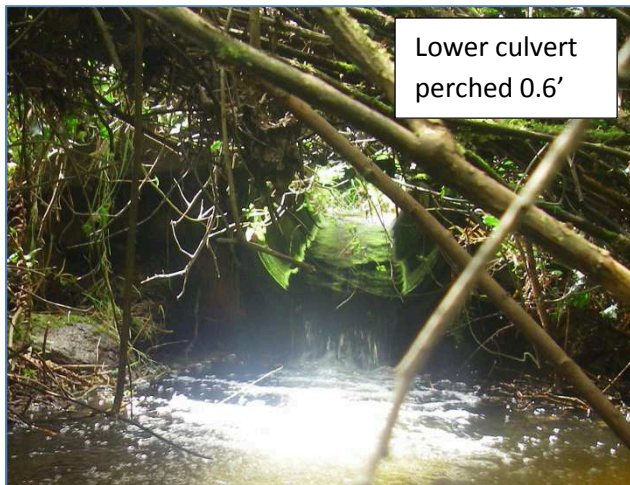
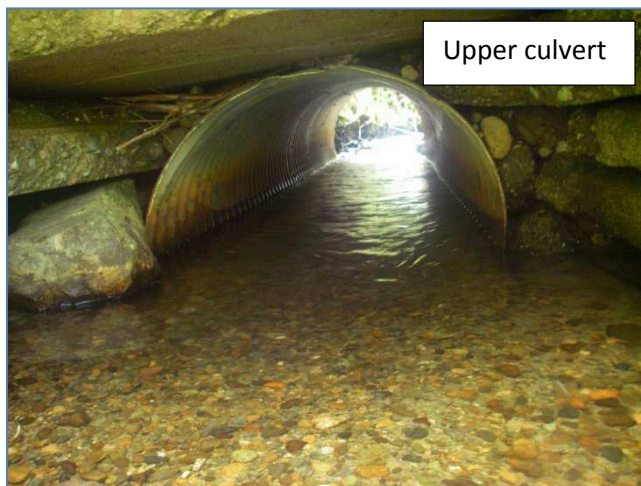
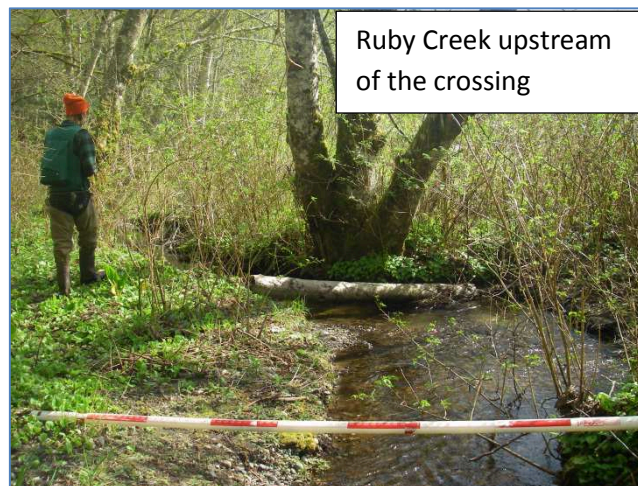
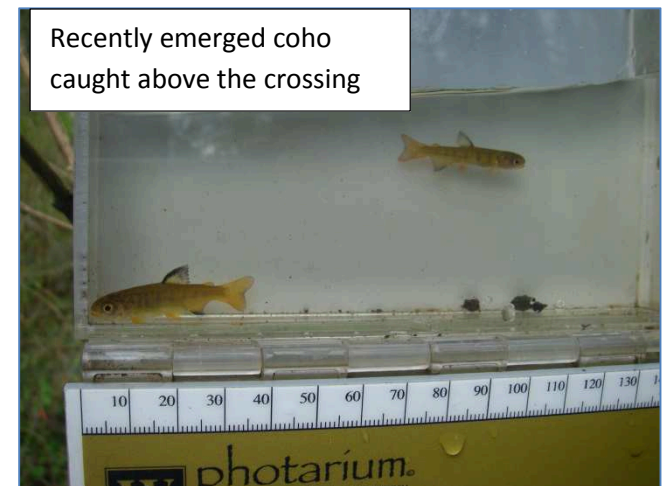
**The Problem:** Ruby Creek crosses 2 private drives off the end of Harper RD. The lower culvert is a partial barrier and is perched 0.8'. Both the upper and lower culverts are undersized at 2' span and are unable to carry flows generated by high rain events. The undersized culverts have caused scour along the private drive. This could be an excellent FFFPP project.

**Proposed Solution:** Replace the culverts with structures large enough to pass high flows and improve fish passage.
