Wild Fish Conservancy Watertype Assessment Project Summary WRIA 13 Phase IV (15-1176)

June 2019

WRIA 13 Assessment Project –Phase III

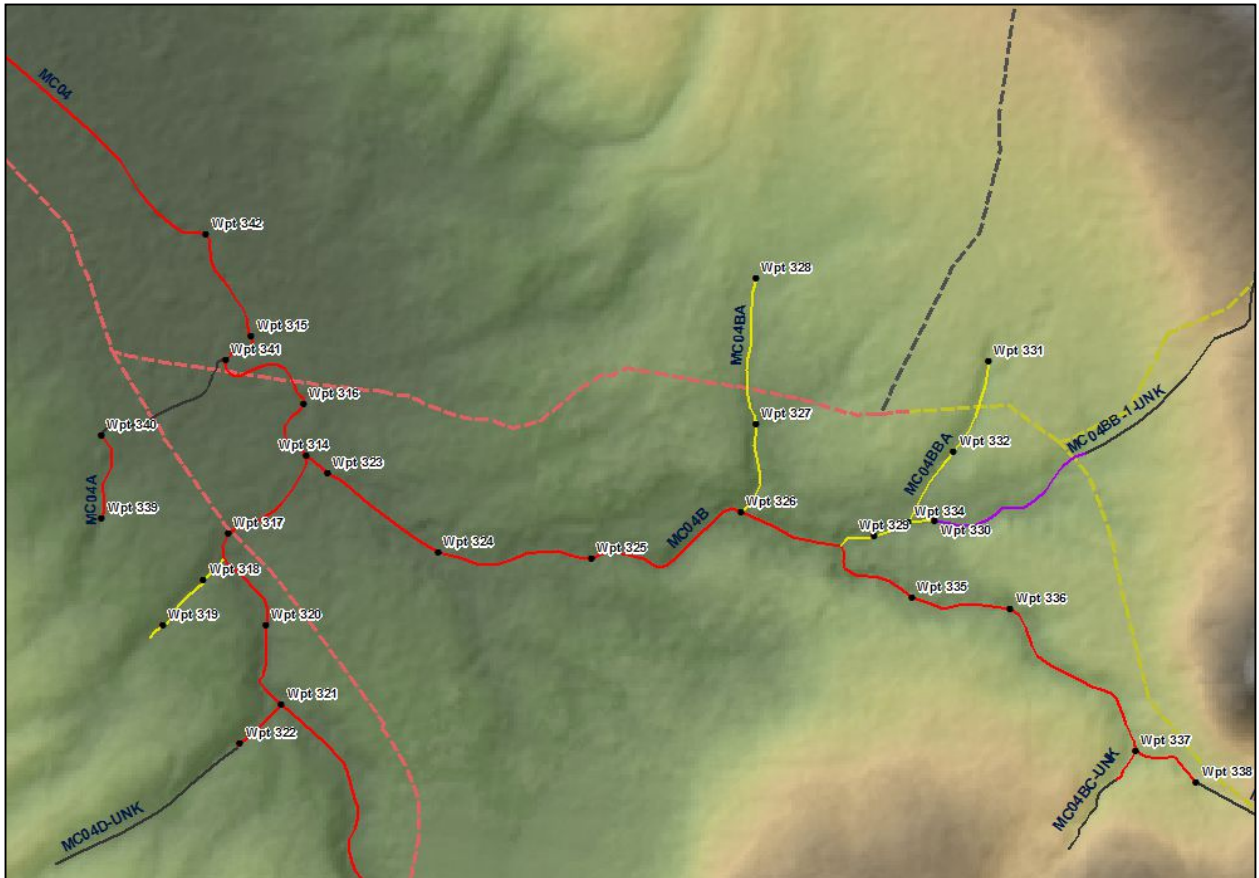
Figure 2. Example of discrepancy between DNR modeled stream channel location (dashed) and classification, and WFC field observations (solid).

As expected based on previous Wild Fish Conservancy water type assessments, significant discrepancies existed between the Washington Department of Natural Resources (WDNR) regulatory maps and what we found on the ground (Figure 2). For example, over the study area WDNR had identified 419 miles of streams. WFC found that 13 miles of those WDNR mapped channels did not exist, but that an additional 11.4 miles of stream channels did exist that were not on the official WDNR water type maps.

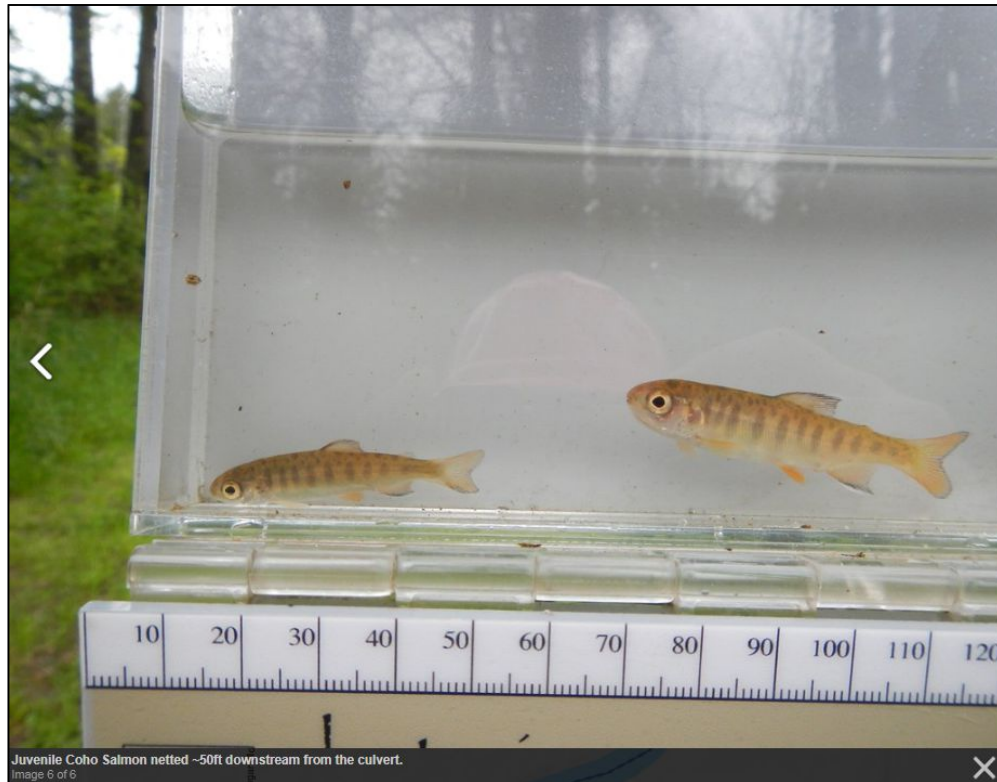
Figure 3. Young of year coho salmon captured in an unnamed mis-mapped tributary during the WRIA 13 Phase IV Water Type Assessment.

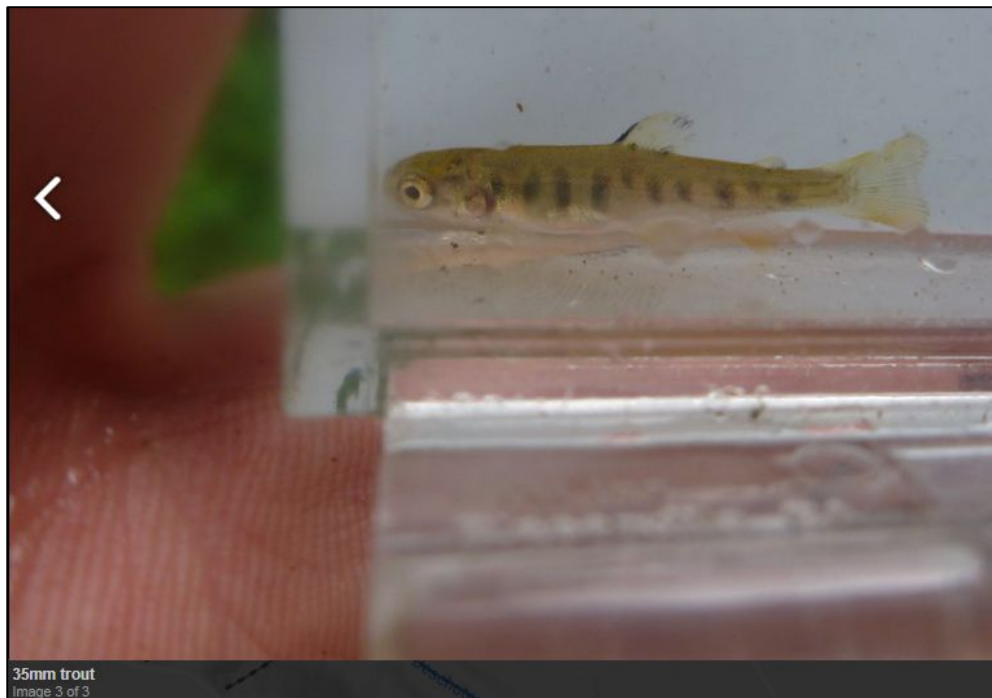
Figure 4. Young of year trout captured in Silver Creek during the WRIA 13 Phase IV Water Type Assessment.

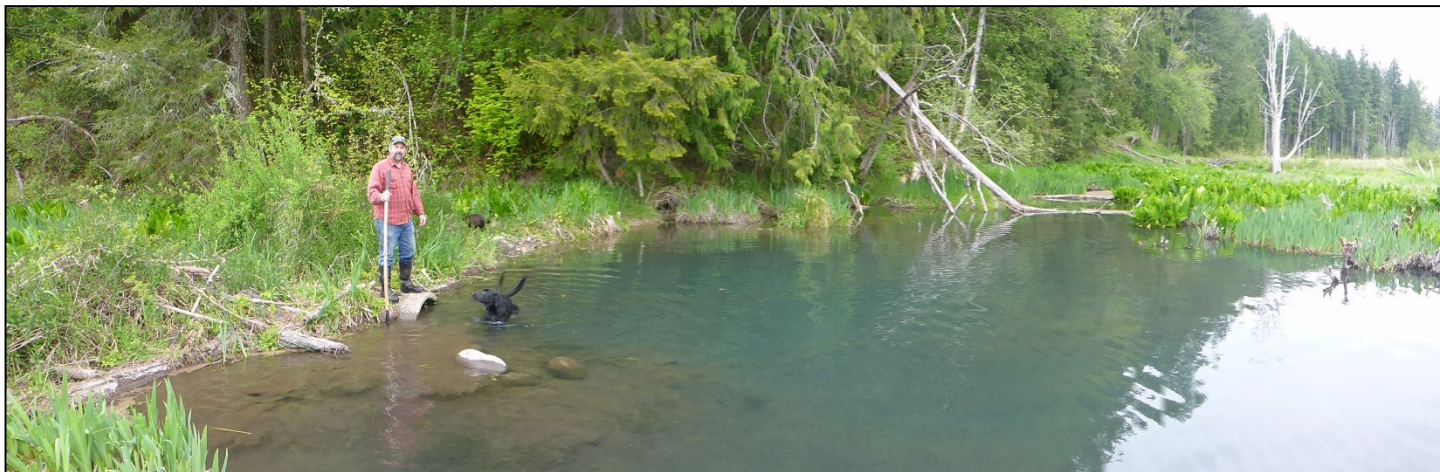
Figure 5. Fish access restoration project (identified as Project “D” in Appendix A) on Unnamed Deschutes tributary. Several barrier culverts impede fish access to a series of beaver ponds which would provide excellent rearing habitat.

D	DS103	PID 9925	-122.4613,46.7957	http://www.moonlitgeo.com/wfc/?lat=46.7957&lng=-122.4613&zoom=17	Barrier culverts on abandoned field access roads and modified channel with grazing impacts	Remove culverts and restore and improve wetland, instream, and riparian habitat	This channel has a series of beaver ponds and wetlands adjacent to a cattle pasture. The channel has been altered and ditched to improve drainage to pasture land. Excellent opportunity to restore the channel and adjacent wetland habitat. The land owner is eager to restore the stream function and riparian corridor.
E	DS058	PID 9800	-122.6356,46.8451	http://www.moonlitgeo.com/wfc/?lat=46.8451&lng=-122.6356&zoom=17	Degraded stream and wetland actively grazed by cattle and horses	Install livestock fencing, plant native riparia, naturalize channel	A type F low gradient stream flows through a wetland in an active cow and horse pasture. The stream is choked with non-native grasses including reed canary grass with no native riparian trees and shrubs. This section of stream lacks protection from grazing and is crossed regularly by both cattle and horses. This location marks an excellent opportunity to protect and restore the channel (install livestock fencing, add LWD, and add native riparia).
