Wild Fish Conservancy Watertype Assessment Project Summary West Sound Watersheds Phase III

September 2016

West Sound Watertype Assessment Project –Phase III

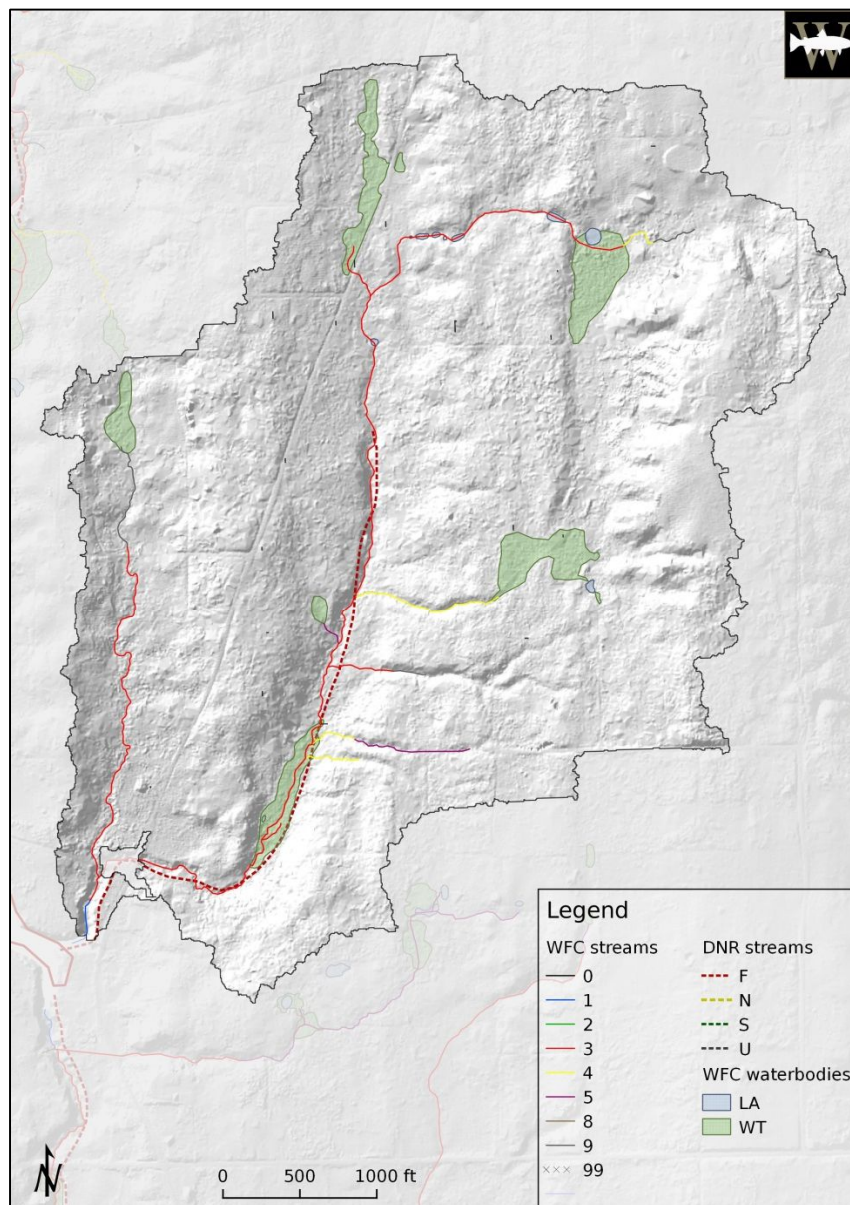
Figure 2. Westsound Phase III example of discrepancy between DNR modeled stream channel location and classification, and WFC field observations.

As expected based on previous Wild Fish Conservancy water type assessments, significant discrepancies existed between the Washington Department of Natural Resources (WDNR) regulatory maps and what we found on the ground (Figure 2). For example, over the study area WDNR had identified 211 miles of streams. WFC found that 15.4 miles of those WDNR mapped channels did not exist, but that an additional 57.5 miles of stream channels did exist that were not on the official WDNR water type maps.

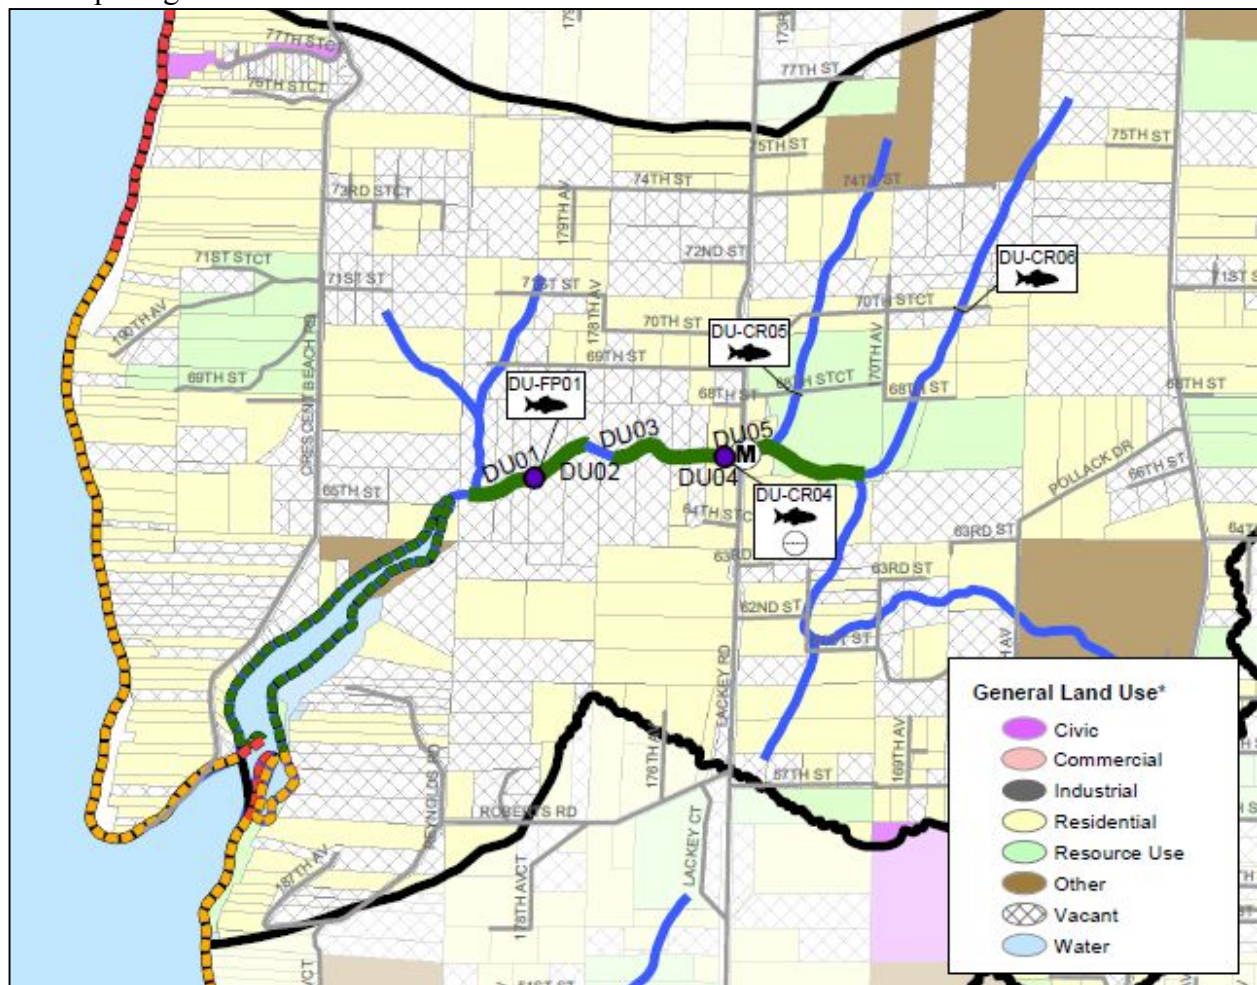
Map excerpted from Figure 4-7 from Key Peninsula - Island Basin Plan (Pierce County, 2006) shows dam+fish ladder at site DU-FP01, and the Lackey culvert at DU-CR04.

DU-FP01 on the map below is an earthen dam with a failing fish ladder. While WFC did not have access to that site, info is provided in the Key Peninsula - Island Basin Plan (Pierce County, 2006). Further, the site was a short-lived Family Forest Fish Passage Program project until it was withdrawn, so there is additional information in PRISM under project #05-1408 (SPSSEG).

DU-CR04 on the map below is an undersized failing culvert at Lackey Rd. that is a partial barrier to fish passage.

Lackey Rd. culvert outlet, with culvert sections in plunge pool. This undersized 5.0 foot span culvert should be replaced with a 16 foot box culvert or bridge. In conjunction with improving passage at the downstream earthen dam, restoring fish passage here would improve spawning and rearing habitat to almost 3 miles of mainstem and tributary channel to Coho, Steelhead and Cutthroat trout. Additional photos and data are available on WFC's interactive web map at: <http://wildfish.beardedmaps.com/?lat=47.31707&lng=-122.76959&zoom=19>

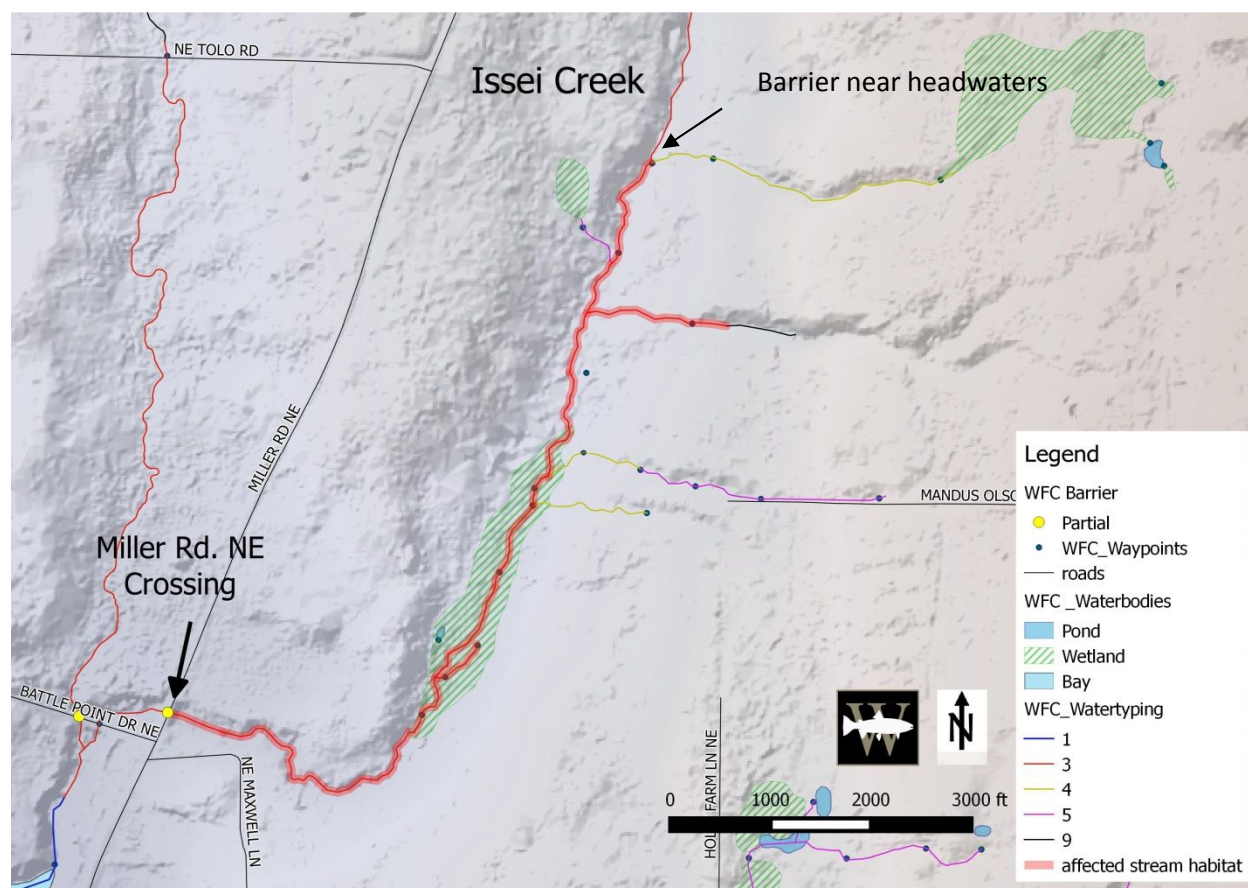
Issei Creek provides over a mile of excellent fish habitat on Bainbridge Island. Beginning in wetland headwaters, the stream meanders through a lush second growth forest in the Grand Forest Park before feeding into Fletcher Bay. During field surveys WFC found the two culverts draining Issei Creek under Miller Rd. NE to be partial barriers to upstream fish migration and disruptive to natural stream processes. The two culverts, also described as partial barriers by WDFW culvert inventories, are undersized and fail to transport Issei Creek's water/sediment/wood during high flow events. This has resulted in downstream bank erosion and scouring. There is now a 1 ft perch and a plunge pool at the outlet of the culverts. Cutthroat trout, coho and rainbow trout were documented both above and below the crossing.

Solution

Replace the two side by side 2 ft. culverts under Miller Rd. NE. with a large single culvert or bridge. Remove the downstream English Ivy and invasive Bamboo. Revegetate the riparian corridor with native plant species to increase bank stabilization.

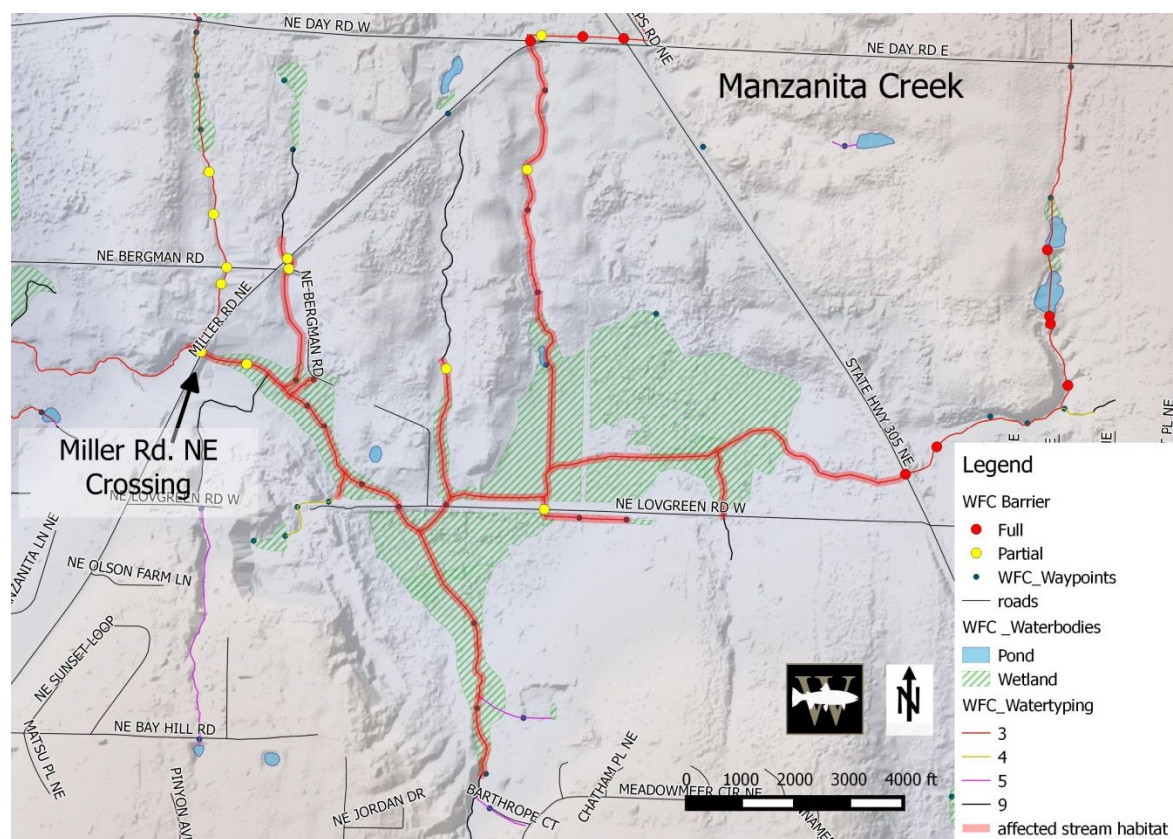
Manzanita Creek is one of the largest watersheds on Bainbridge Island, and provides habitat for numerous fish and amphibian species. There were multiple restoration opportunities and partial barrier culverts found on this system during WFC's field survey, though the majority were in the headwaters of this system. The most prominent disruption to fish migration and natural stream process was found where Manzanita Creek is piped under Miller Rd. NE. Here, the concrete culvert is 3 ft in diameter and the outfall is perched 1.3 ft. The undersized culvert constricts flow during high flow events resulting in substantial downstream erosion and a large plunge pool. This plunge pool has a rock weir at its outlet which was likely installed to raise the water level of the pool and thus improve fish passage to the culvert. There is a second pool and weir approximately 10 ft. downstream. The culvert was also found to be a partial barrier by WDFW culvert inventories conducted in 2014.

Solution: Replace the undersized and perched culvert with a larger culvert capable of carrying Manzanita Creek's flows during all flood cycles. Remove or redesign the downstream weirs and regrade the stream channel to match the new culvert. Replant the riparian corridor to improve bank stability.

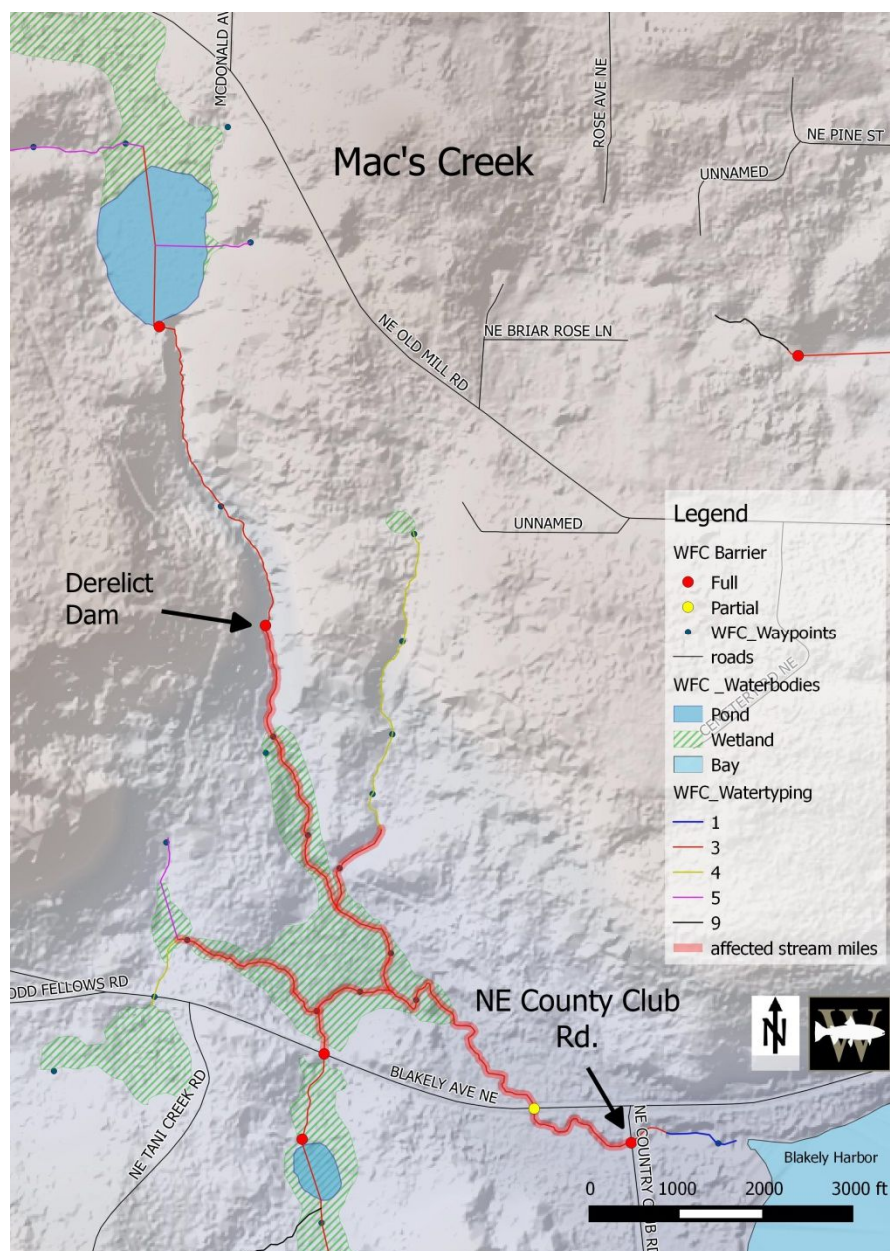
Derelict Dam on IslandWood:

education center has shown great interest in removing the dam if the NE Country Club Rd. culvert was replaced and fish once again had access to their property.

Solution

Replace the undersized culvert on NE Country Club Rd. with a large box culvert or bridge. Install grade controls / roughness in the channel above the culvert which is currently incised. Remove the extensive english ivy above the crossing and revegetate the riparian corridor with native plant species. Coordinate with the IslandWood education center to remove the derelict dam and restore fish passage and sediment/wood transport.
