## Wild Fish Conservancy Watertype Assessment Project Summary

### West Sound Watersheds Phase II

October 2014

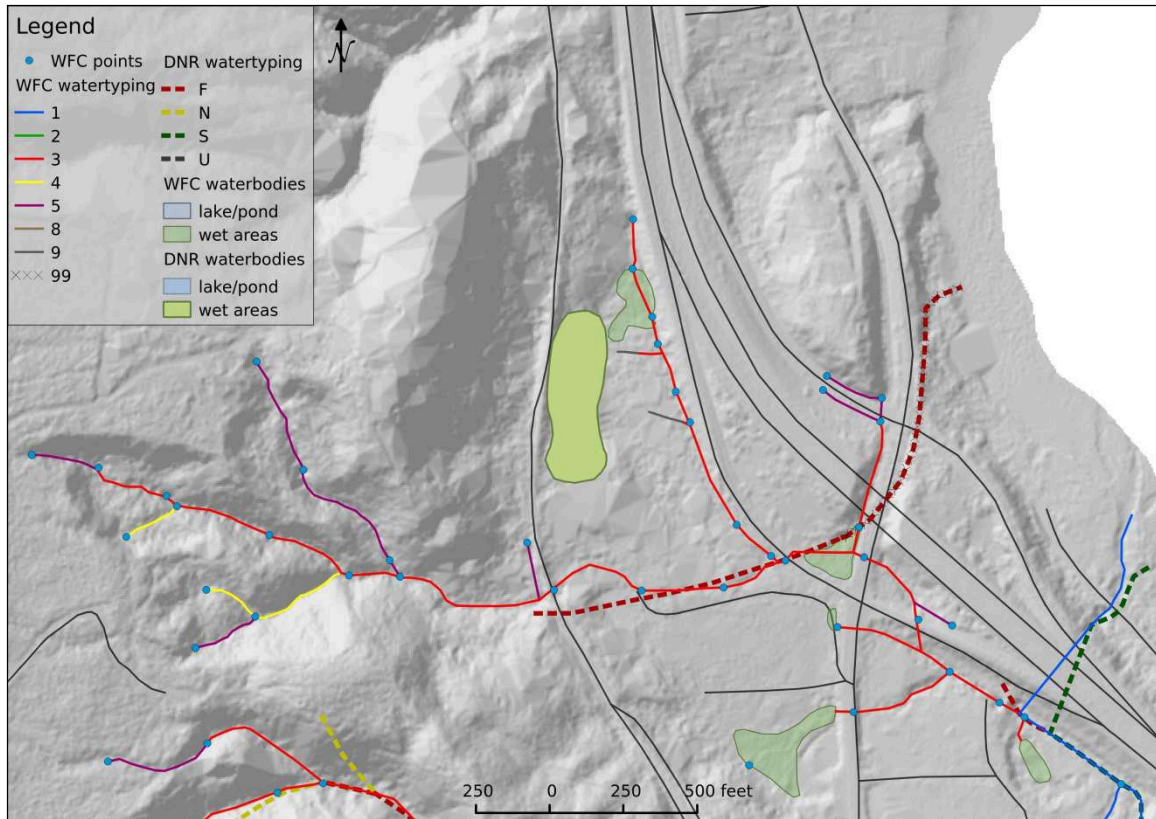
Figure 4. Example of discrepancy between DNR modeled stream channel location and classification, and WFC field observations. This is an unnamed left-bank tributary at the mouth of Chico Creek near Bremerton.

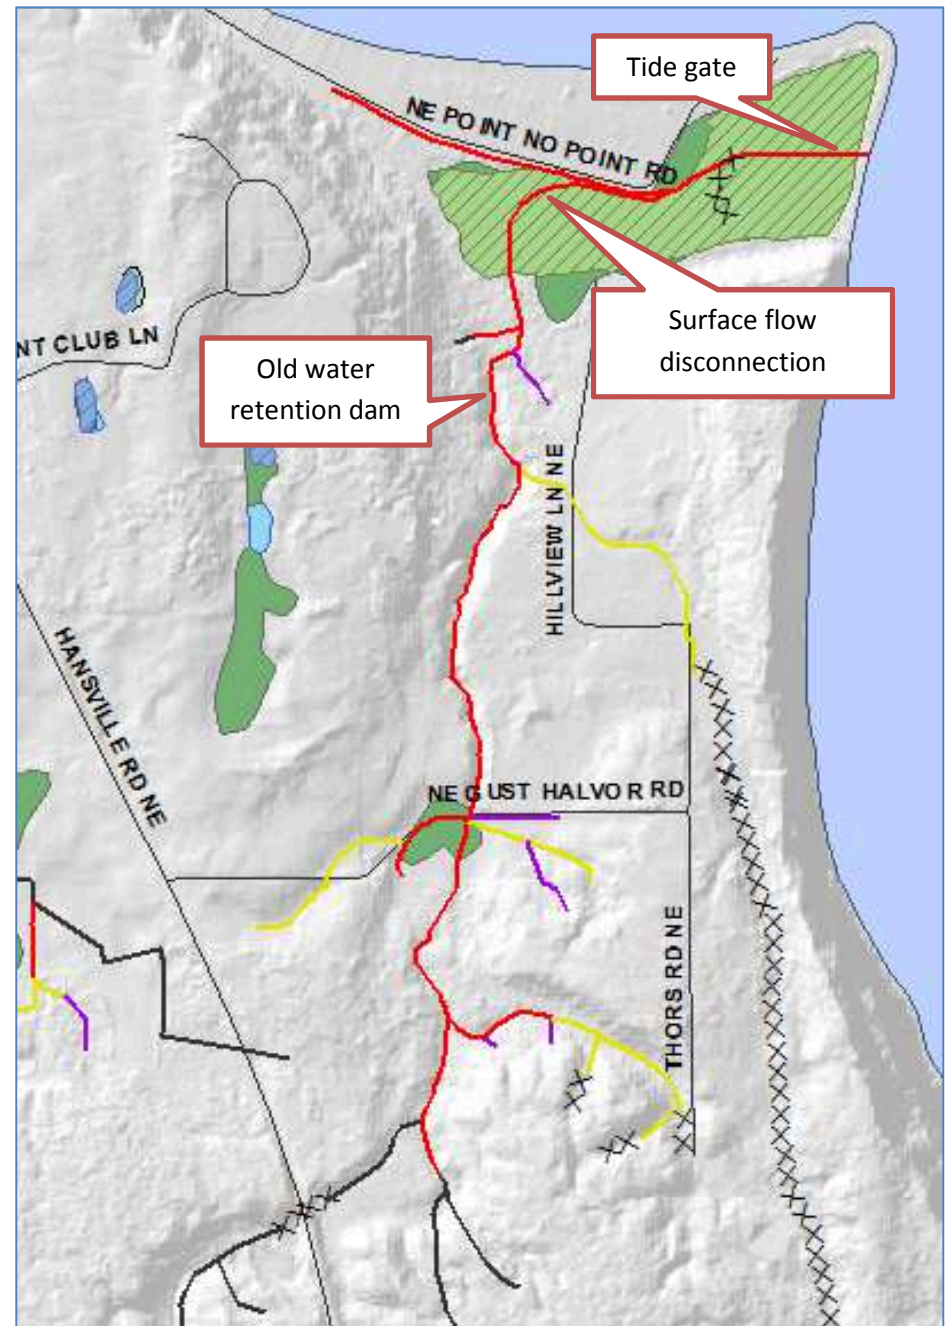
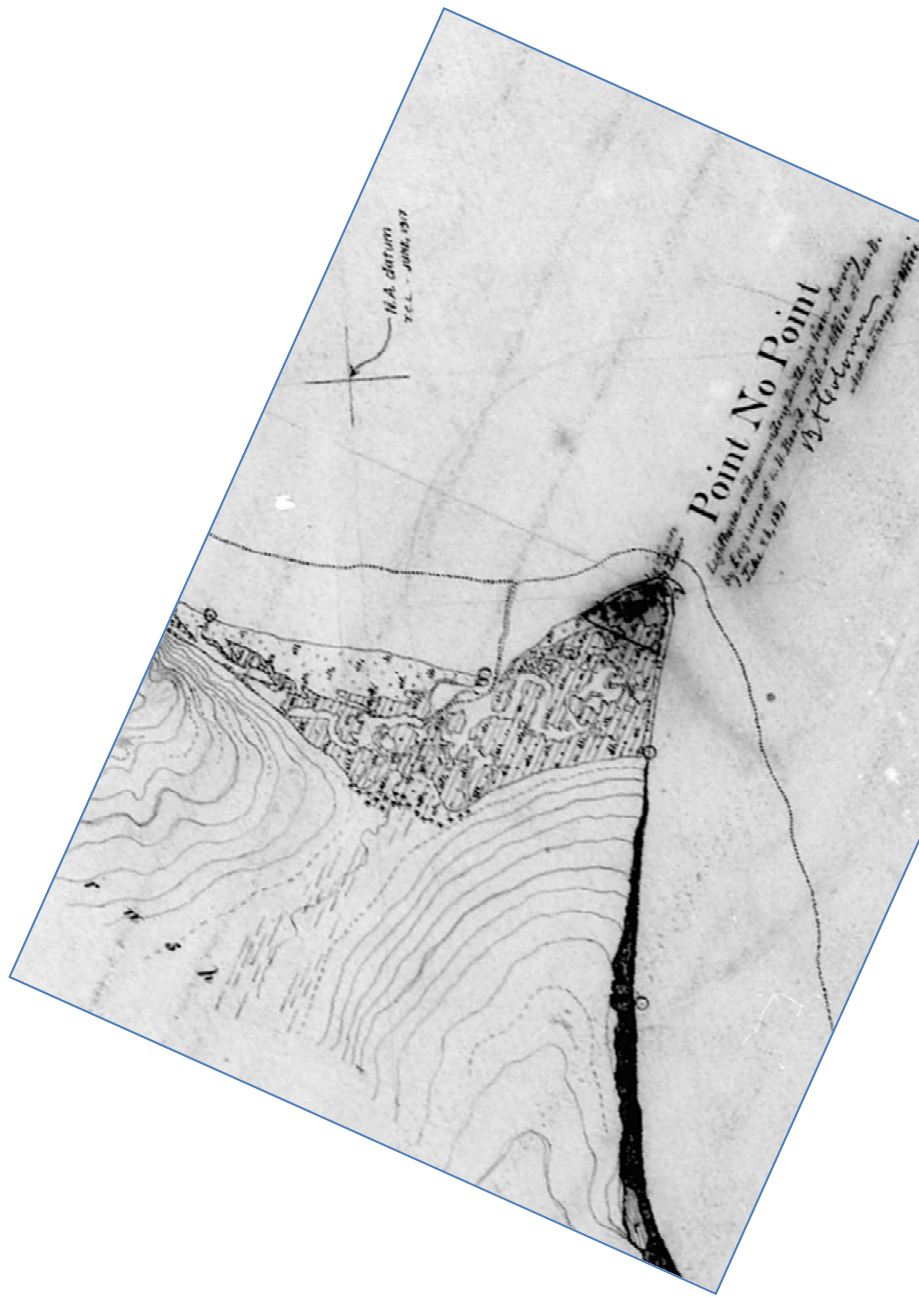
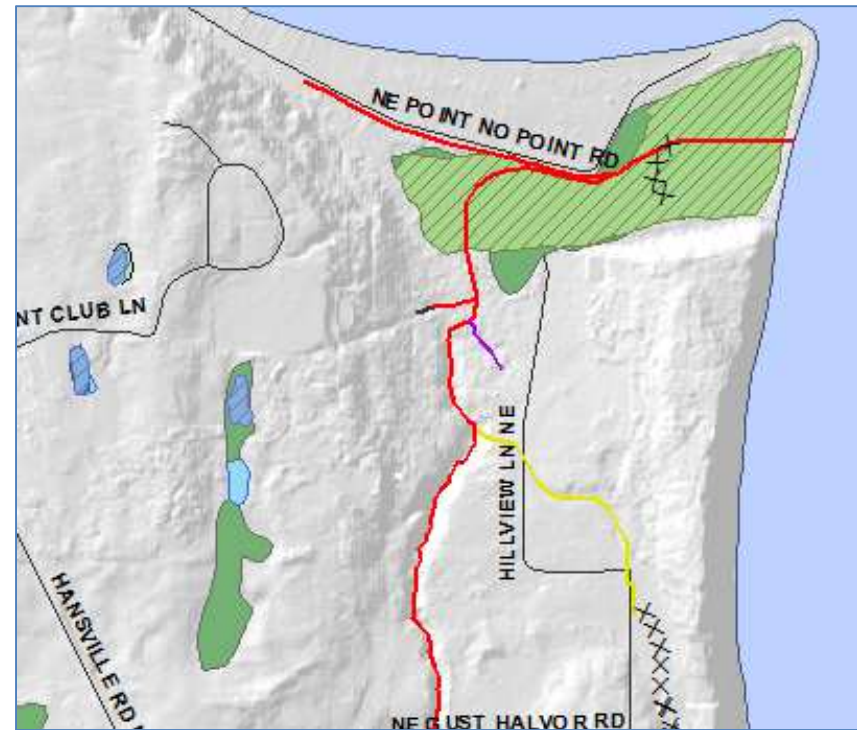
T-sheet (on left) showing location of salt marsh and contributing watershed in 1857.

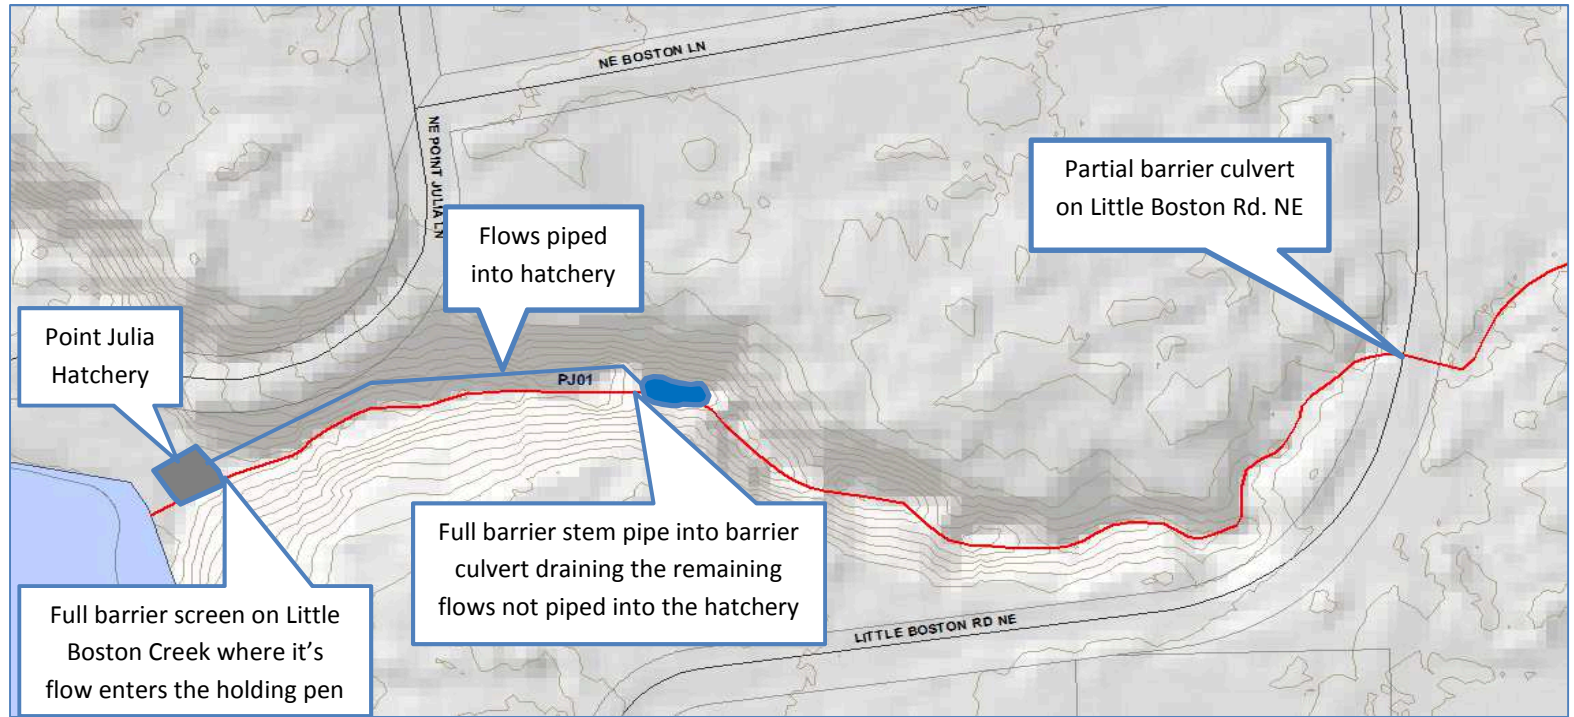
**The Problem:** The outlet of the intake reservoir for the downstream hatchery is a full barrier to fish passage. The diversion partially de-waters 450 feet of the mainstem channel. The flow which is not piped into the hatchery runs out the overflow structure to continue downstream the mainstem. This overflow passes through a debris screen and drops 5' into a concrete vault. The vault then drains into a 2.5' culvert which is buried under the downstream bank and is perched 2' at its outlet.

**Proposed Solution:** Restore fish passage around the reservoir.

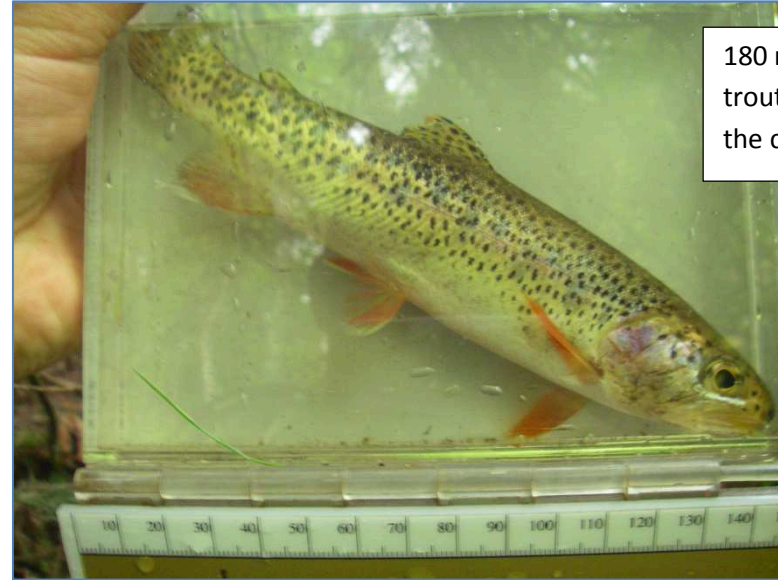
**The Problem:** Little Boston Creek crosses Little Boston Rd. NE in an undersized culvert perched 1'. Cutthroat trout were netted above and below this partial barrier culvert.

180 mm cutthroat trout netted below the culvert

**Proposed Solution:** If downstream habitat is restored this culvert may be a good candidate for replacement, improving fish passage.

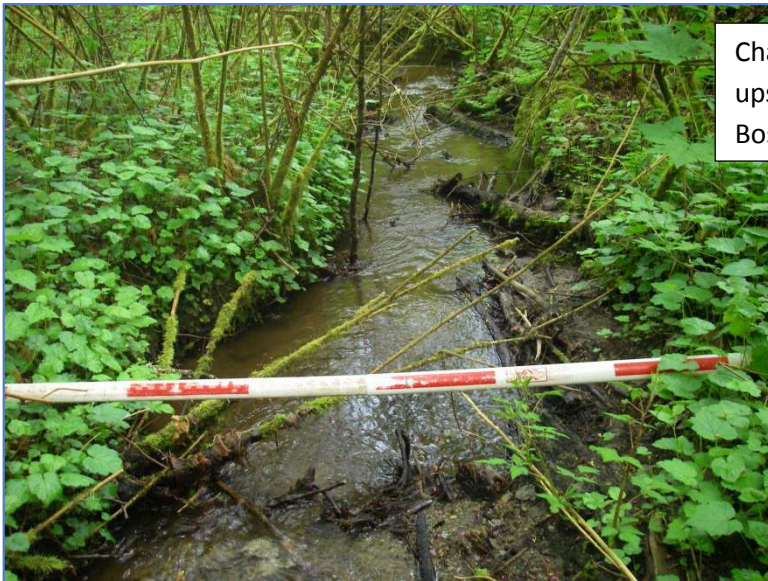
Channel upstream Little Boston Rd. NE.

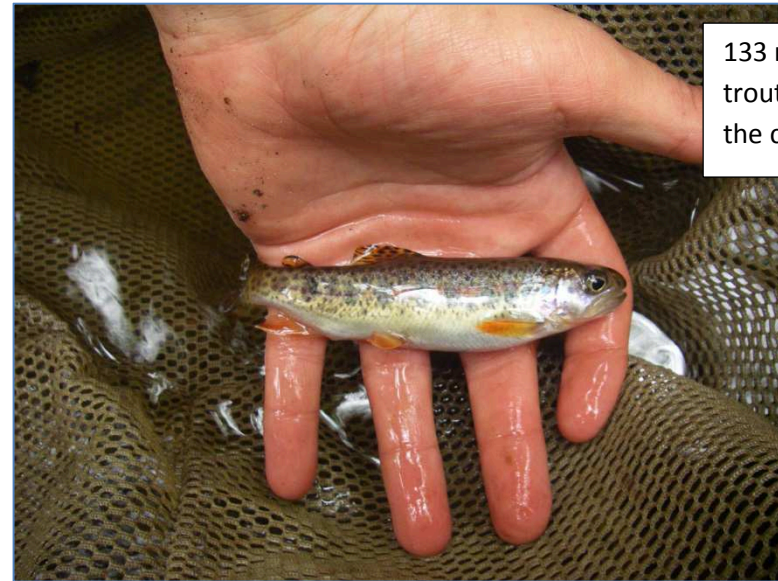
133 mm cutthroat trout netted above the culvert

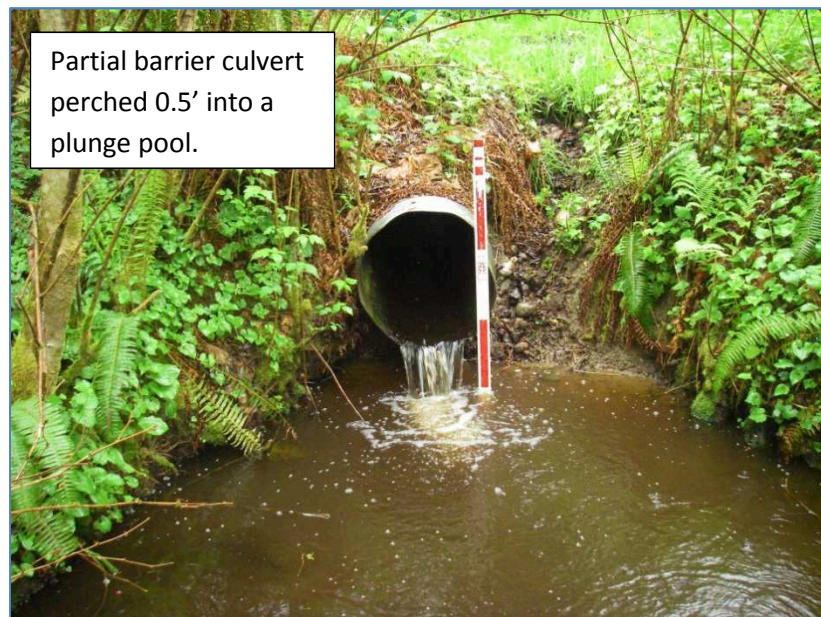
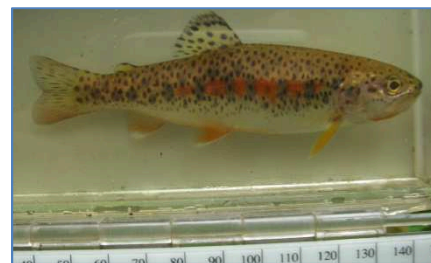
118 mm cutthroat trout caught in the plunge pool at the culvert outlet

**Proposed Solution:** Replace culvert to improve fish passage

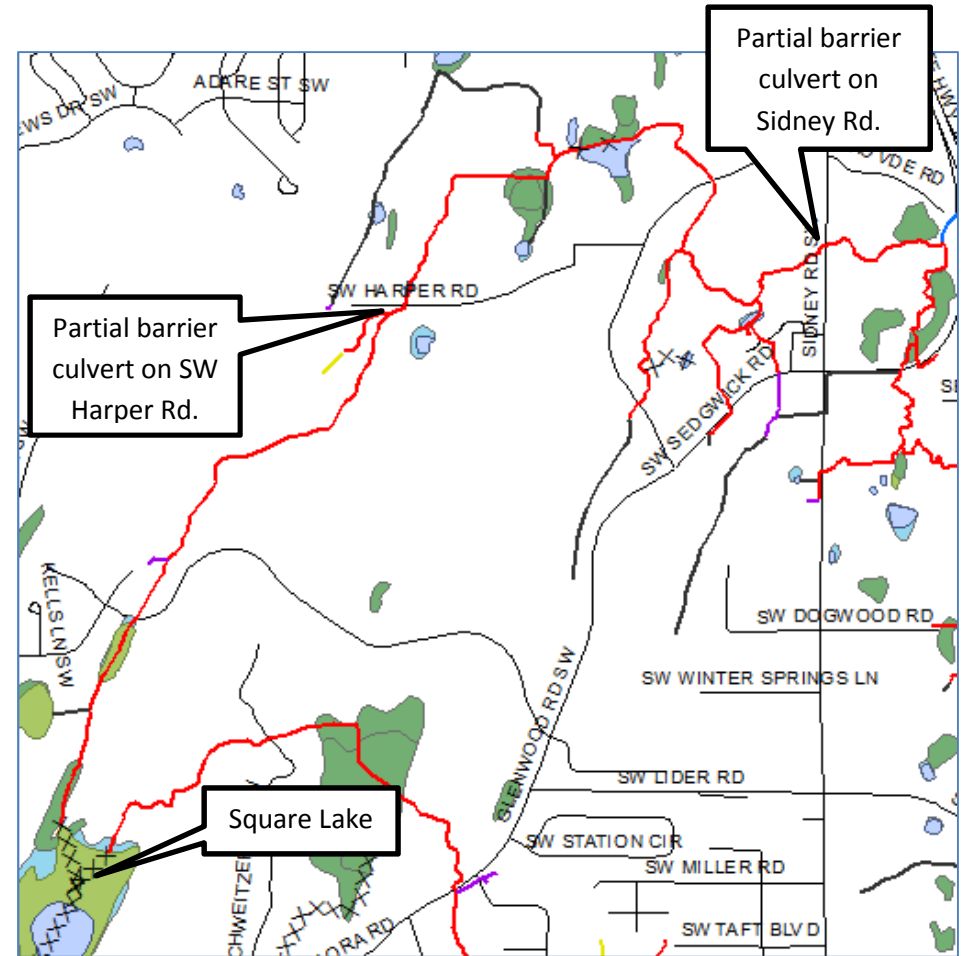
**The Problem:** Ruby Creek crosses 2 private drives off the end of Harper RD. The lower culvert is a partial barrier and is perched 0.8'. Both the upper and lower culverts are undersized at 2' span and are unable to carry flows generated by high rain events. The undersized culverts have caused scour along the private drive. This could be an excellent FFFPP project.

**Proposed Solution:** Replace the culverts with structures large enough to pass high flows and improve fish passage.
