**20-1192 - DESCHUTES TRIBUTARY
RESTORATION PLANNING**

Preliminary Design and Design Report

July 2022

DESCHUTES-MEYER RESTORATION PROJECT PERMIT LEVEL PLANS

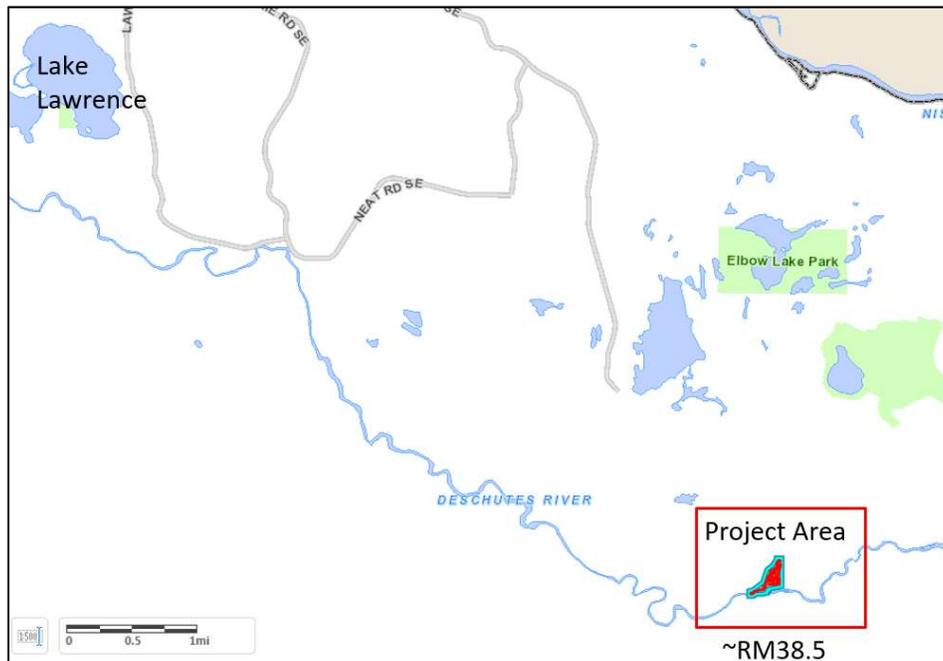
Figure 1. Project area within the Deschutes River.

Meyer Creek joins the mainstem Deschutes River from the north (right-bank) at river mile 38.5, 20140 SE O'Toole Rd. (Figure 1). The Deschutes R. Coho Salmon Biological Recovery Plan (2015) identifies river miles 31-41 as the most utilized coho spawning areas in the watershed. The mainstem Deschutes River within this reach has limited suitable rearing habitat and elevated summer water temperatures. Recommended restoration actions include reducing fine sediments, increasing the availability of complex habitats and reducing high water temps. Meyers Creek is a spring-influenced wetland channel complex that has the potential to provide cold-water refugia and rearing habitat for coho and other native temperature-sensitive fishes.

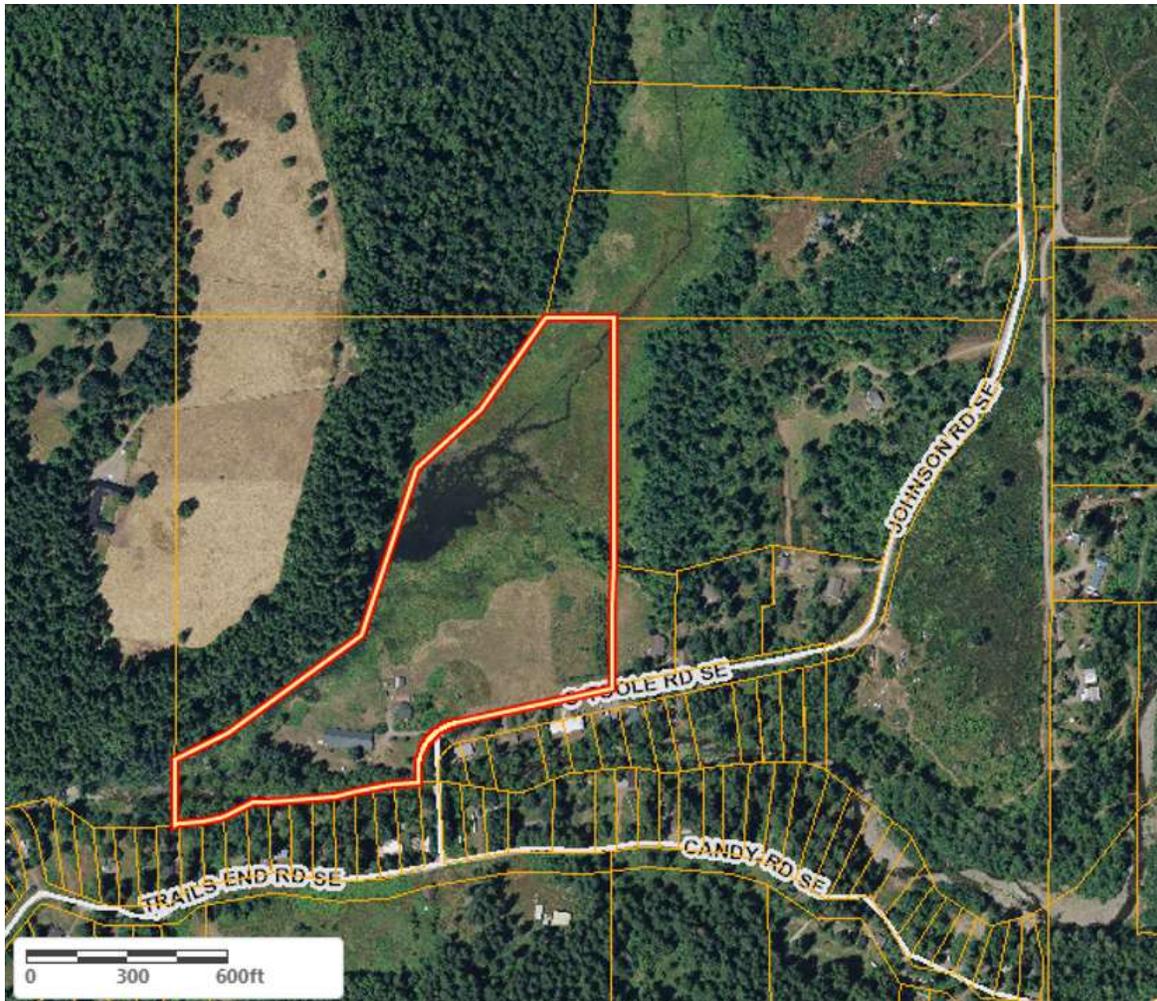
Figure 2. 22-acre project area at the downstream end of the Meyer tributary.

Meyer Creek flows south through a wide valley in a complex of spring fed wetlands, and beaver ponds (Figure 2). During the last century, the stream has been impacted by agricultural practices within the valley. Impacts include ditching and straightening portions of the stream channel; grazing livestock in and adjacent to the stream, beaver ponds, wetlands, and riparian areas; and the presence of three derelict culverts. Portions of the lower reaches of the site are infested with invasive flag iris and Himalayan blackberries.

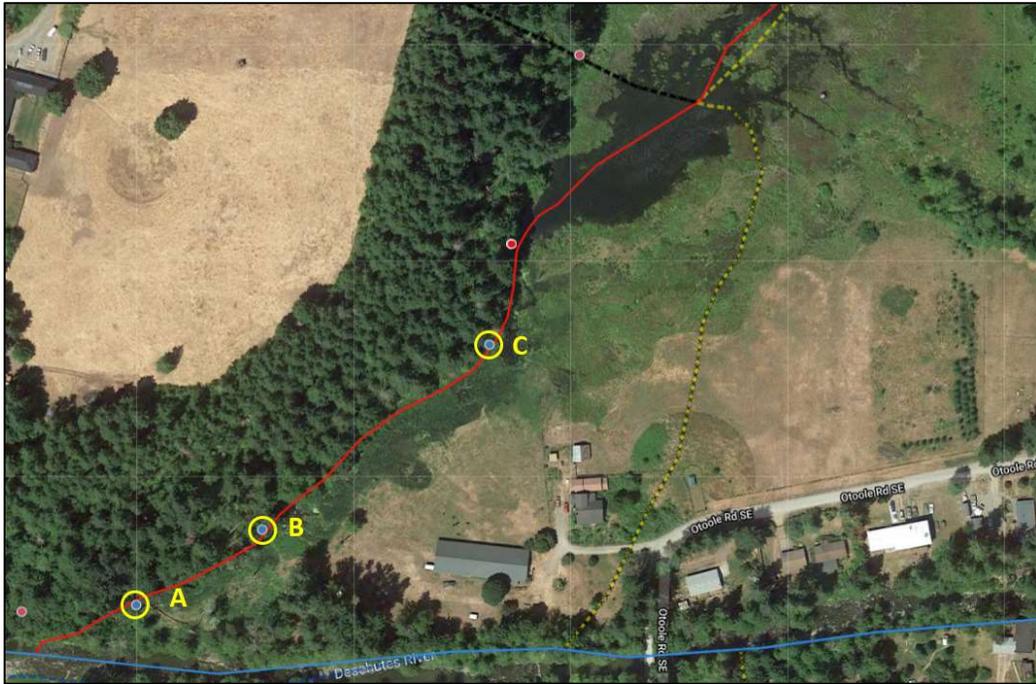
Figure 3. Locations of three derelict concrete culverts.

Three derelict 4.0 foot diameter concrete culverts currently impede fish access from the mainstem Deschutes River to Meyer Creek and compromise the downstream delivery of sediment, wood, and water (Figures 3 and 4). The culverts are no longer in use by the landowner.

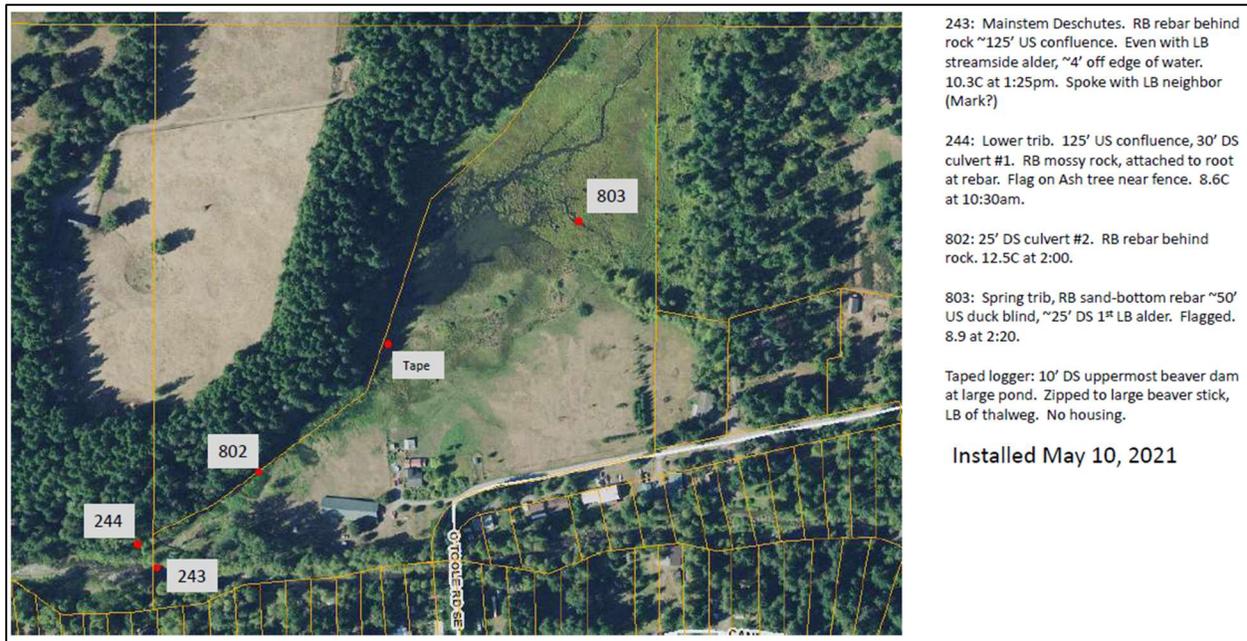
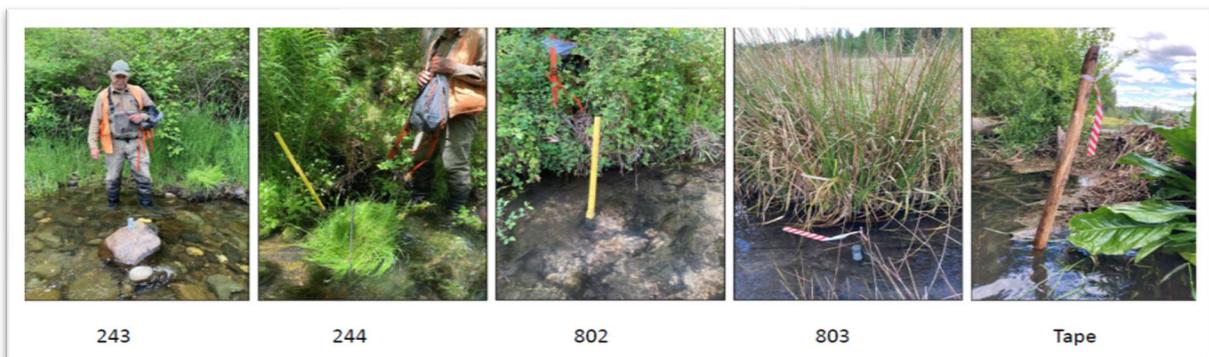
Figure 5. Locations of five Hobo © water temperature loggers which were in place between May 10 and October 19, 2021.

The project team installed five Hobo © temperature data loggers to record water temperatures during summer 2021 (Figure 5). Wild Fish Conservancy installed the loggers on May 10, 2021 and removed them on October 19, 2021. Raw hourly temperature data for all the sites are available upon request.

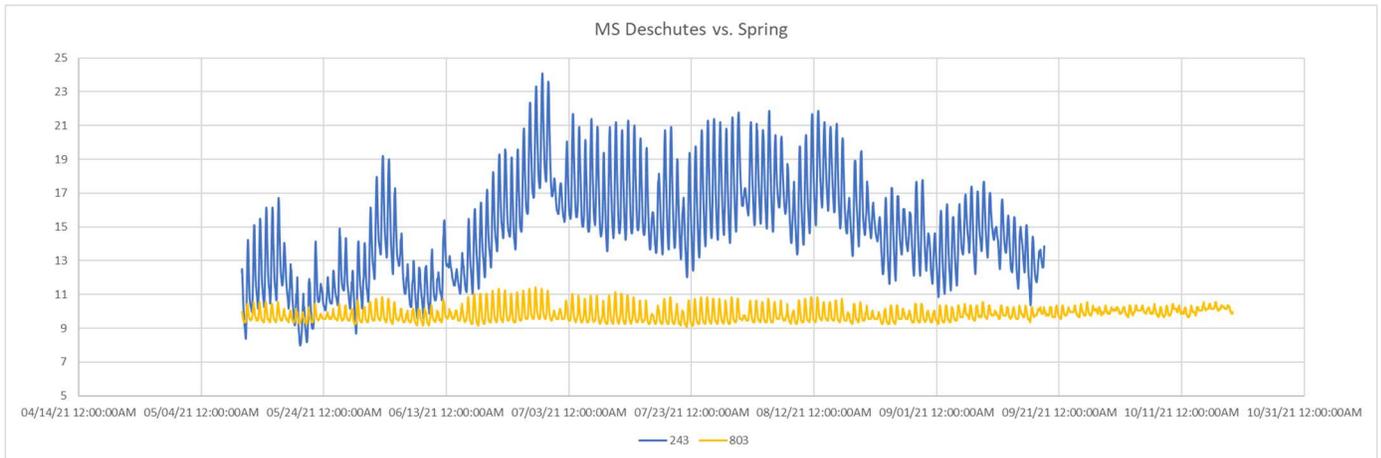
Figure 6. Mainstem Deschutes River (Site 243, in blue) water temperatures relative to the Meyer spring (Site 803) during the June 2021 heat dome.

The temperature data collected during summer 2021 captured the late June heat dome, demonstrating the relatively cool and constant water temperatures (10 degrees C) delivered by the spring channel (temp logger 803) relative to the mainstem Deschutes River, which peaked at 24 degrees C during that extreme event (Figure 6).

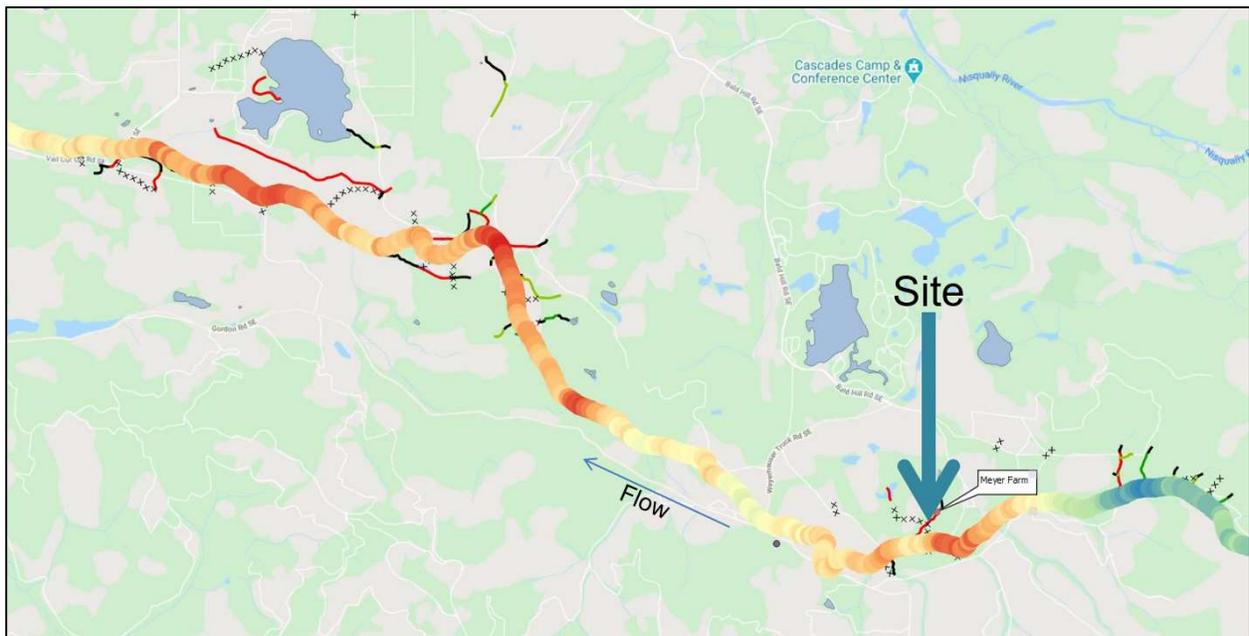
Figure 7. Mainstem Deschutes FLIR data from the Department of Ecology’s Deschutes TMDL effort. Reaches of higher water temperature are shown in red.

The team also created a GIS using mainstem Deschutes forward-looking infrared (FLIR) water temperature data collected by the WA Dept. of Ecology during the development of the Deschutes River 2015 TMDLs (Figure 7). The data illustrate the elevated mainstem water temperatures in the vicinity of Meyer Creek, affirming the importance of this cold-water low gradient rearing habitat.

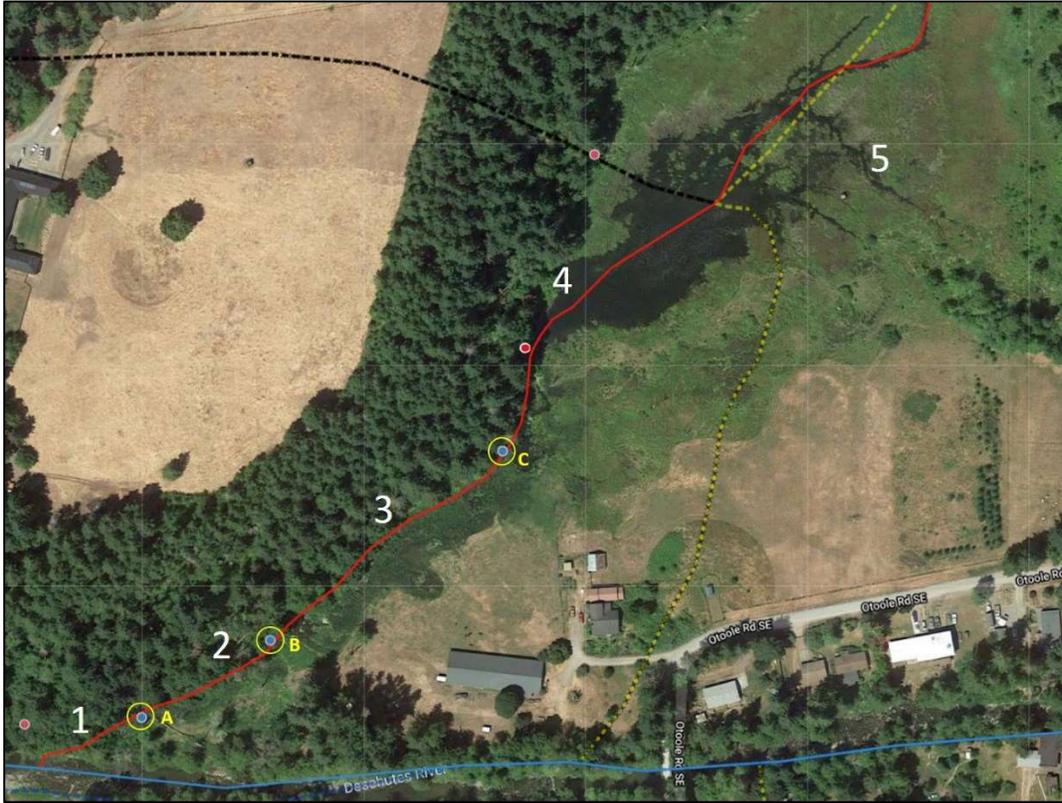
Figure 8. WFC sampled fish in five sub-reaches within the project reach.

On May 10, 2021 WFC performed a fish species composition and distribution survey of surveyor-accessible habitats within the project reach. Five sample reaches were surveyed systematically in an upstream direction (Figure 8).

WFC conducted single-pass electrofishing where possible, however portions of the backwatered and ponded reaches were too deep, and the substrate was too soft, to safely electrofish. In reaches 2 and 4, minnow traps (1 and 4, respectively) were baited with bloodworms and left for six hours during the sampling day. Three sculpin were captured in one trap within reach 2, no other fish were trapped. Several 7-10-inch cutthroat trout were observed in the beaver ponds but were not brought to hand. A school of ~10 young-of-year coho were observed in the mainstem Deschutes just upstream from the confluence. Juvenile coho were also observed in Reach 1 downstream from the barrier culvert “A,” but not upstream (Table 1, Figure 9).

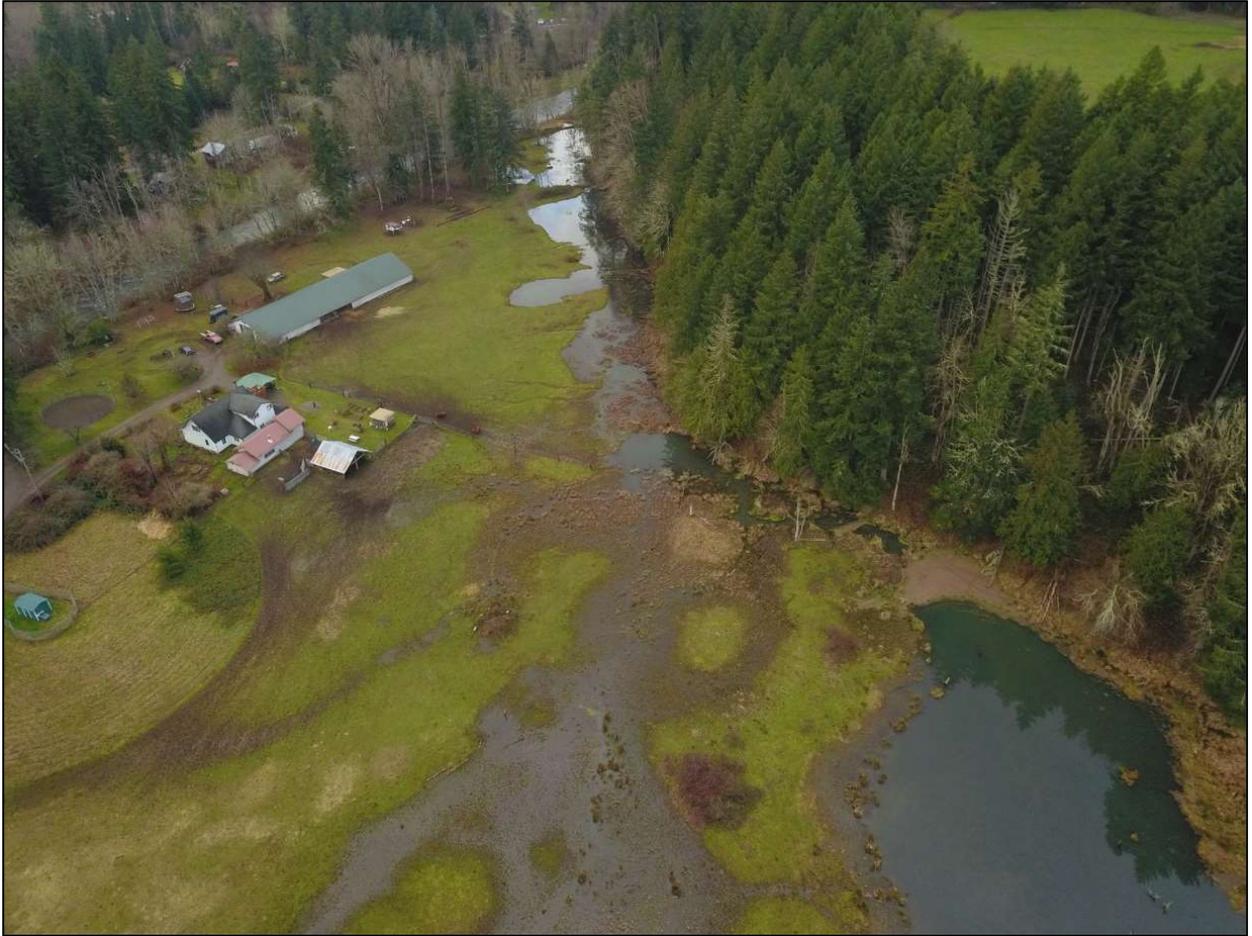
Figure 10. Wild Fish Conservancy digitized aerial photos from January 9, 2021 to create a shapefile for flood extents that informed the preliminary designs.

To document the channel-adjacent topography and extent of flooding, Wild Fish Conservancy digitized aerial photographs collected using a drone during a flood event on January 22, 2021 (Figure 10).
